TOWN OF ARBORG AND MUNICIPALITY OF BIFROST-
RIVERTON

Facility Condition Assessment

Draft Report

Town of Arborg and Municipality of Bifrost-Riverton
Facility Condition Assessment – Draft Report

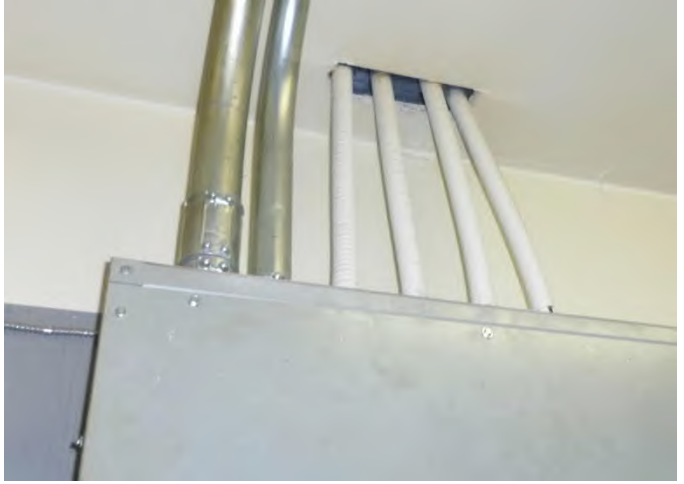
Photo 7 | Cable and conduit transit – Electrical Room # 3

- Replace CDP in Electrical Room #3;
- Replace CDP and panels in Electrical Room #1 and 2;
- Seal conduit and cable transits through wall;
- Emergency lighting for locker rooms;
- Emergency lighting for Electrical Room # 1 and 2;
- Exterior lighting replacement;
- Ice Plant emergency lighting; and
- Lobby and Service Room LED lighting.

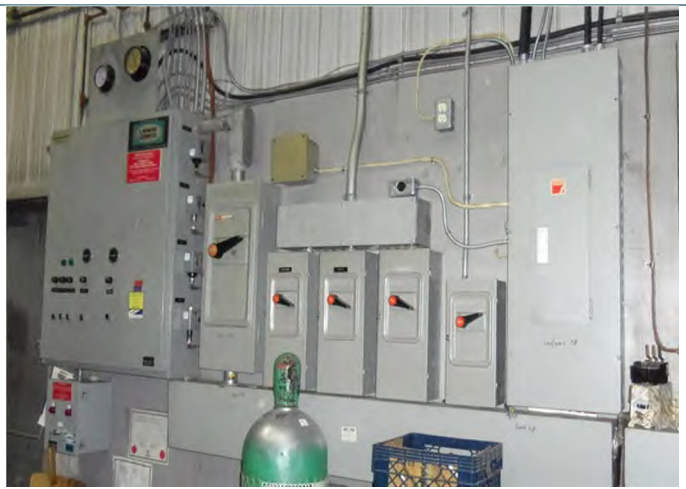
Photo 8 | Ice plant electrical distributor

The Ice Plant electrical distribution equipment should be replaced at the same time as new mechanical ice making equipment is installed.

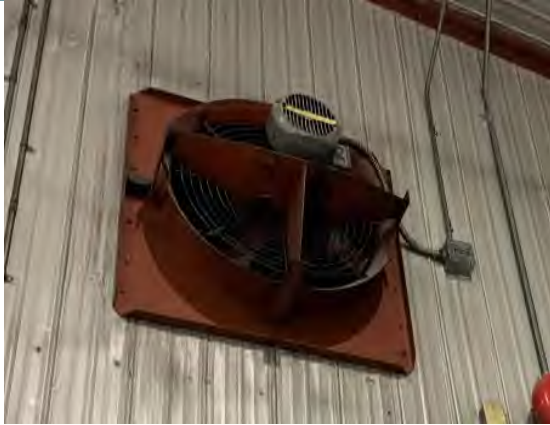
Ventilation for the Ice Rink is provided by wall mounted exhaust fans and intake dampers. The units appear to be original and assumed to be operational. The rink is also equipped with two (2) Seresco dehumidifiers installed in 2014 and have an expected service life of 20 years.

Photo 19 Ice Rink exhaust fan

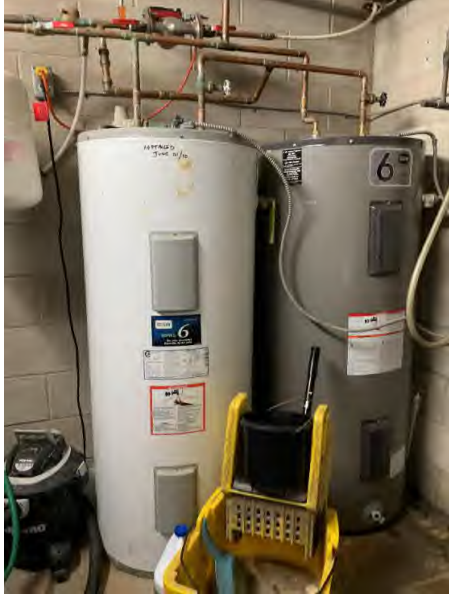
The dressing rooms in the Field House have two domestic hot water tanks, an expansion tank and circulator pump. The tanks and pump were installed in 2010. The hot water tanks and pump are reaching the end of their expected service life of 11 and 10 years, respectively. Plumbing fixtures in the Field House dressing rooms appear to be original. The general condition is poor and signs of corrosion were visible but there was no damage noted. With the exception of the piping at the domestic hot water tanks, the domestic hot and cold water piping in this area of the building is assumed to be original. The piping is painted in some area and appears to be in fair condition. Other areas where piping is exposed are in poor condition. The piping insulation is in poor condition.

Photo 27 Field house hot water tank

- The hot water tanks and recirculating pump serving the Field House can be expected to be replaced within the next year or when maintenance/servicing frequency increases. A cost allowance for the replacement has been provided.
- The hot water tank serving the Lobby and Kitchen area can be expected to be replaced within the next year or when maintenance/servicing frequency increases. A cost allowance for this replacement has been provided.
- The plumbing fixtures in the Field House should be replaced when architectural or structural upgrades are done.

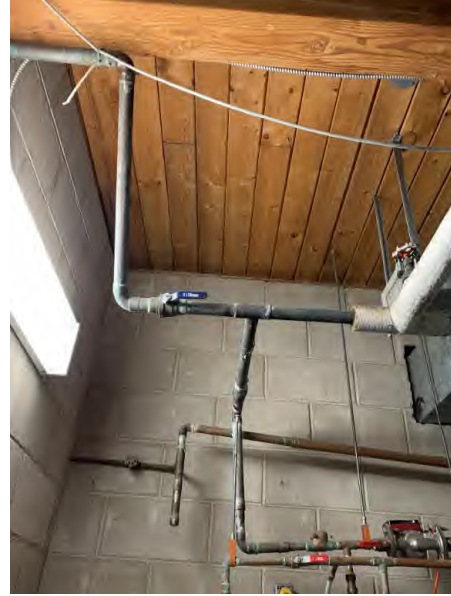
Photo 28 Field House piping

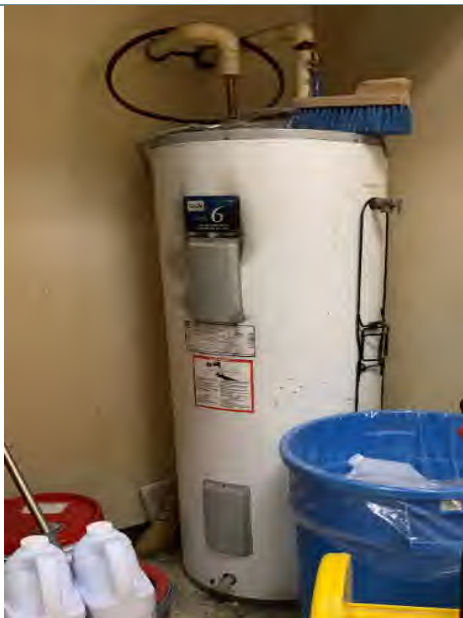
The Lobby and Kitchen Area are served by a dedicated hot water tank installed in the Mechanical/ Electrical Room. The tank is a 4.5 kW 284 L electric hot water, model GSW (6G80SDE1). Based on the serial number it is assumed the tank was replaced in 2007. It is past its expected service life of 11 years. The plumbing fixtures are assumed to be original to the expansion (1990) and are in fair condition. The main sanitary drainage and domestic water piping was concealed by interior finishes. The drainage piping connected where visible was mostly PVC and the domestic water was copper. The piping is expected to last beyond 25 years, assuming no external damage occurs.

Photo 29 Lobby/Kitchen hot water tank

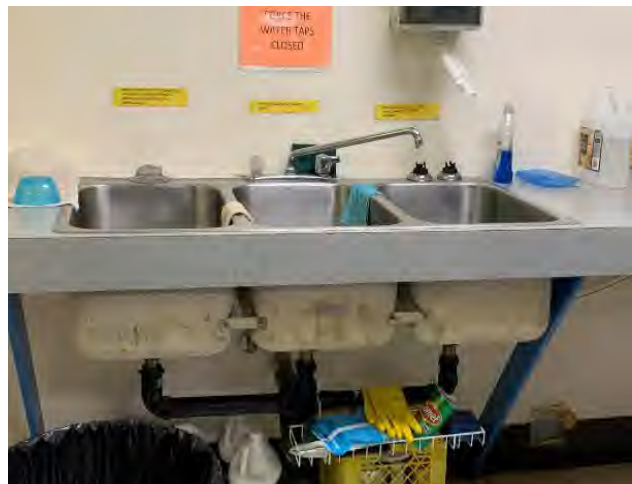
Photo 30 Kitchen plumbing fixtures

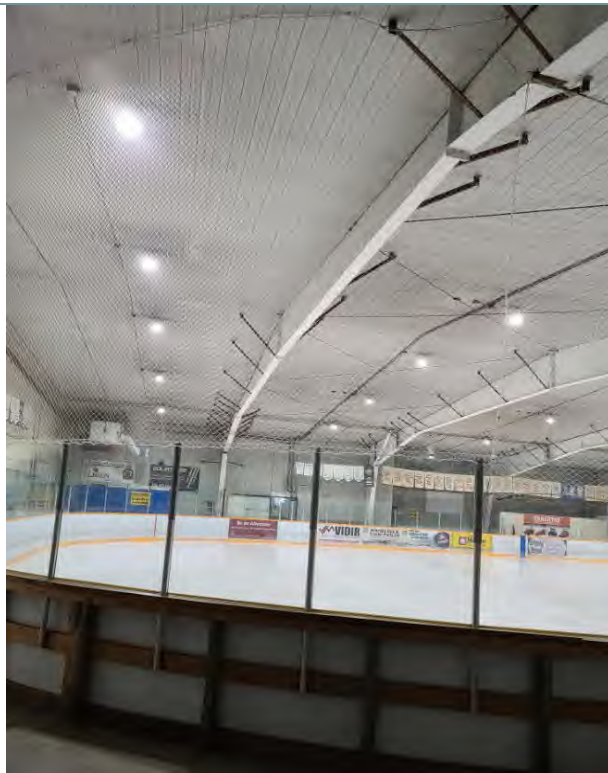
The general conditions of the structural components are in a very good conditions. No signs of rust or deterioration in any exposed structural components.

Photo 31 Pre-engineered steel framing in the Arena

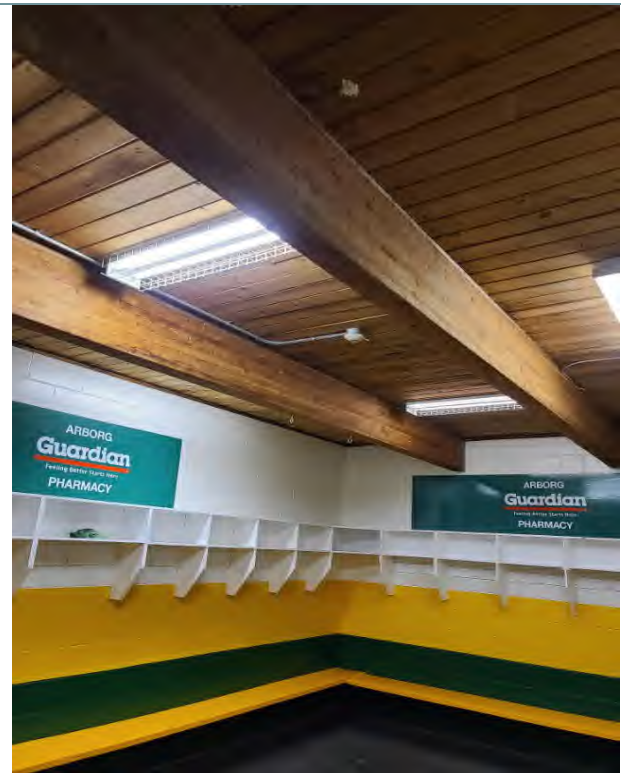
Photo 32 Glulam wood beam and ceiling in the locker room addition to the Arena

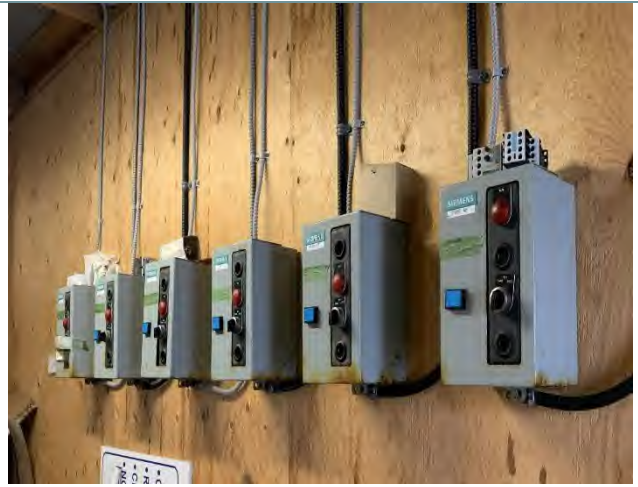
Wall mounted panelboards are approximately 11 years old, as are the other electrical components within the pool pump house. There is corrosion on the edges and corners of some the electrical enclosures. Wall mounted pump controllers appear to have corrosion on the enclosure.

Photo 38 Aquatic Centre panelboards

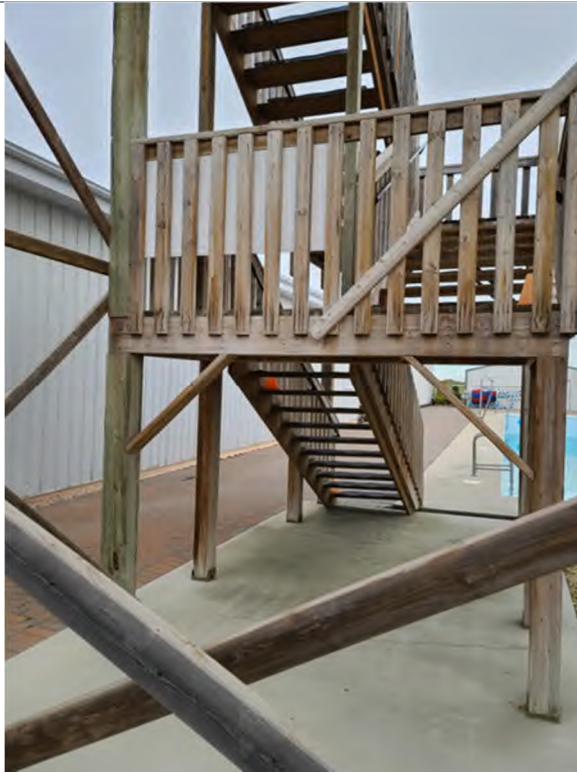
There are two wood structures at the aquatic centre. They are both appear to be in good condition. The photo below shows the condition of one of the stairs to the slider. At one of the connections of the slider segments, the bolts appear to be missing.

Photo 39 A stair framing to the slider

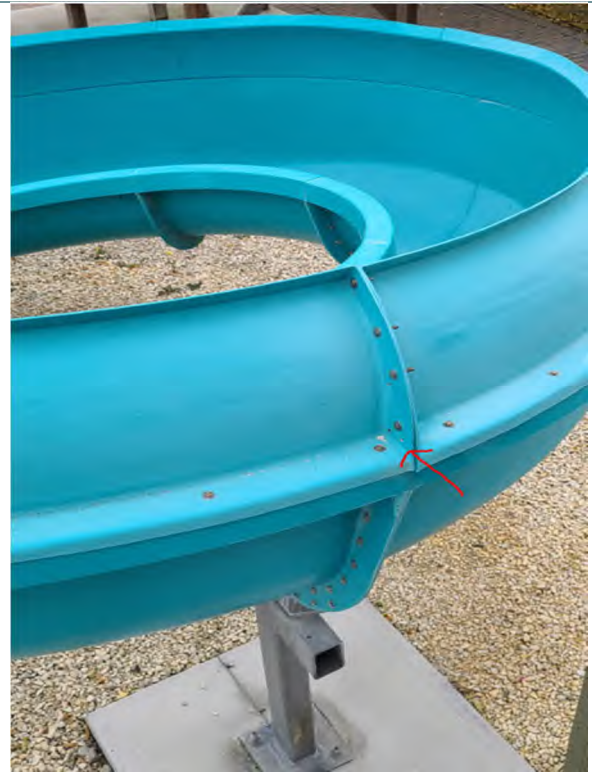
Photo 40 Two bolts are missing at one of the connections of the slider

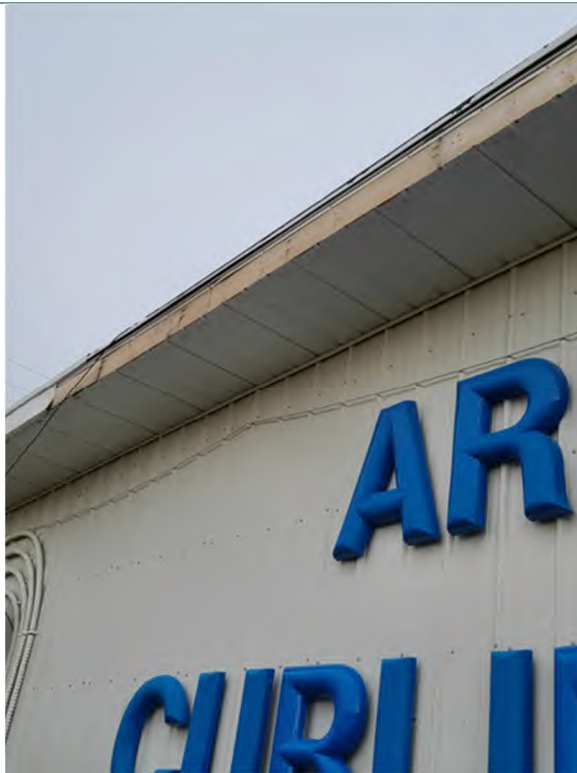
A portion of the fascia cover is missing. The function of the cover is to prevent water from penetrating the fascia board. Leaving the fascia board exposed to water will cause damage to the board and may cause a mould issue. Near the entrance to the building, cracks in masonry joints were observed. This masonry layer serves as an exterior face brick to the mechanical room and is not a structural component. However, the crack will allow water to penetrate into the air space behind this wall and could cause mould issues.

Photo 41 | Missing fascia cover at the Curling Rink

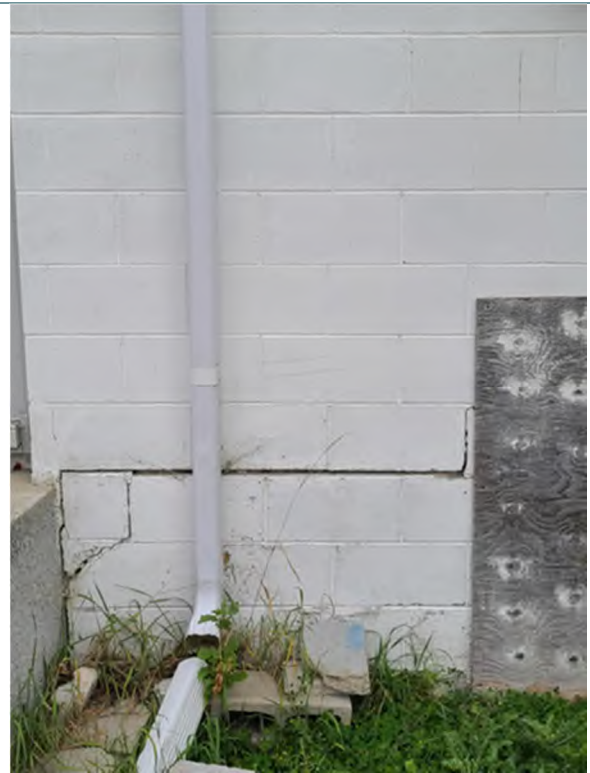
Photo 42 | Cracks in masonry joints

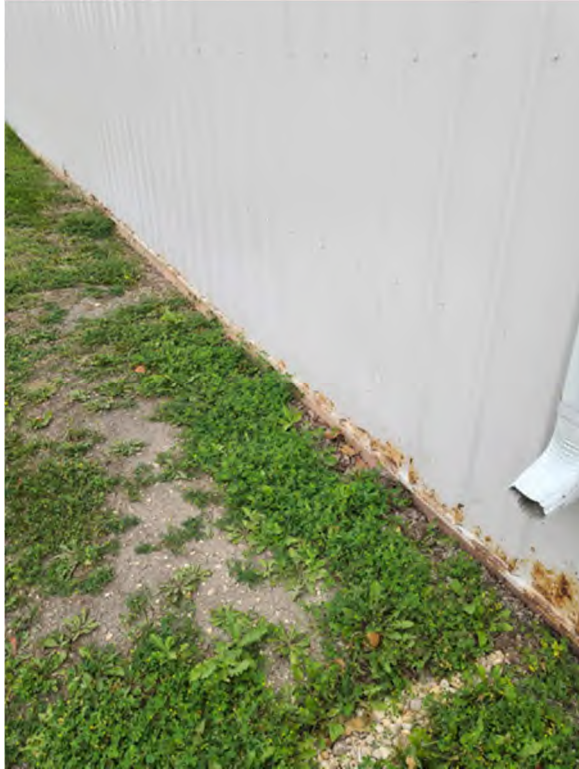
Minor rust was observed at the base of the exterior wall panels. They are not of concern as the rust does not appear to be penetrating through yet. The photo below shows one location at the end of the building where flashing is falling off. Flashings are used to help divert water away from the building. The gutter in the back of the building was observed to be damaged.

Photo 43 Rust observed at the base of the exterior wall panels

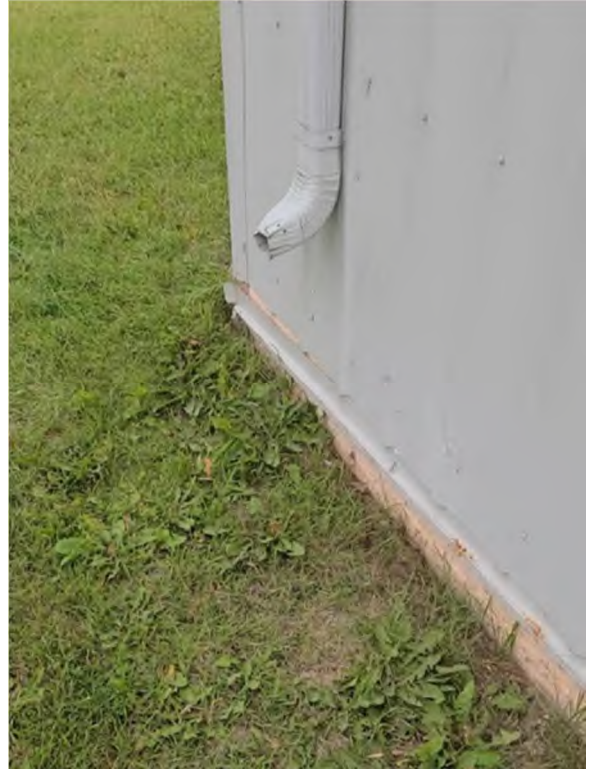
Photo 44 Loose flashing

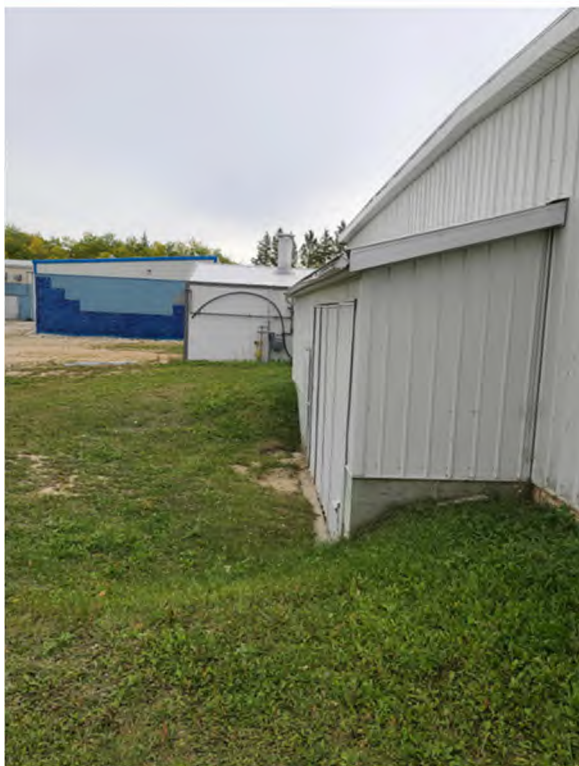
Photo 45 A damaged gutter

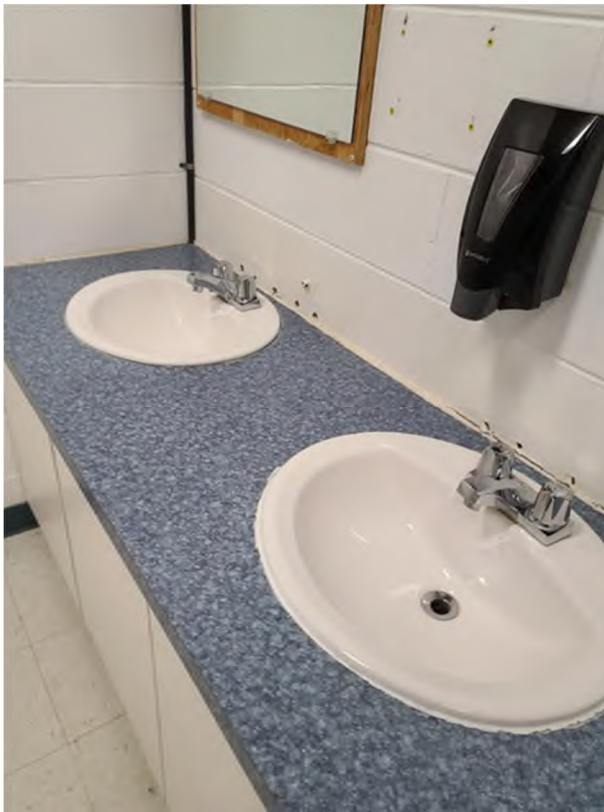
There are holes in the walls in the men washroom. These holes are mostly likely left from the replacement of fixtures. The ceiling tiles in the viewing area appear to be loose in some locations.

Photo 46 Holes on walls in men washroom

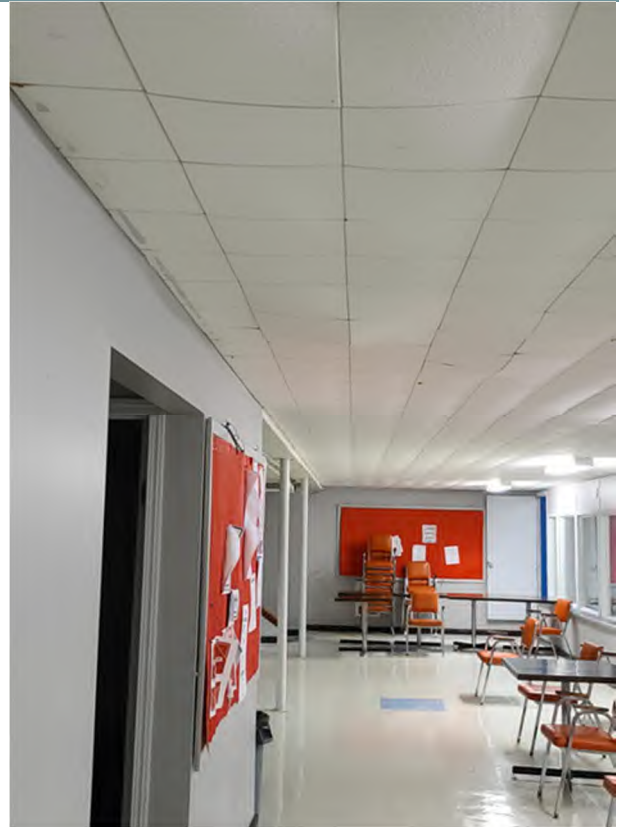
Photo 47 Ceiling tiles in the viewing area

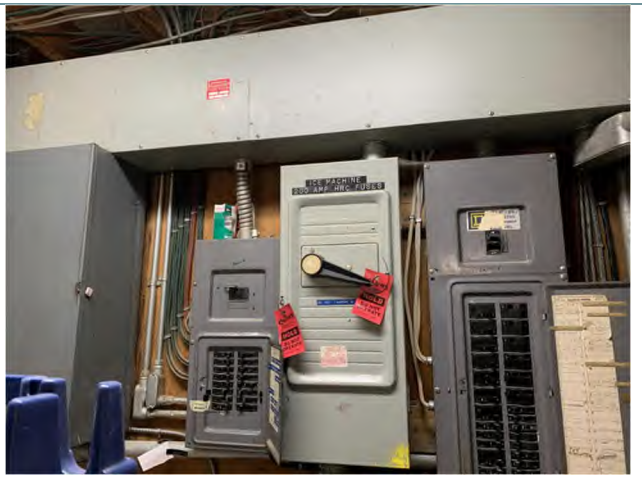
The Arborg Curling Rink was constructed in the mid 90's and the electrical panels and enclosure reflect that style of distribution panels and circuit breakers. The panelboards show no visible signs of rusting and are in good condition. Some enclosures are missing cover plate fasteners. Due to the age of the distribution panelboards, it is recommended that they be replaced with new equipment as they are approaching the end of their expected life span.

Photo 48 | Curling Rink panelboards

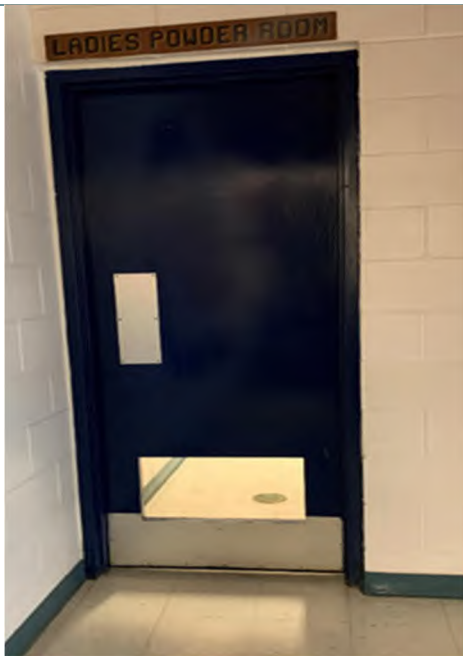
Photo 49 | Curling Rink washroom entrance

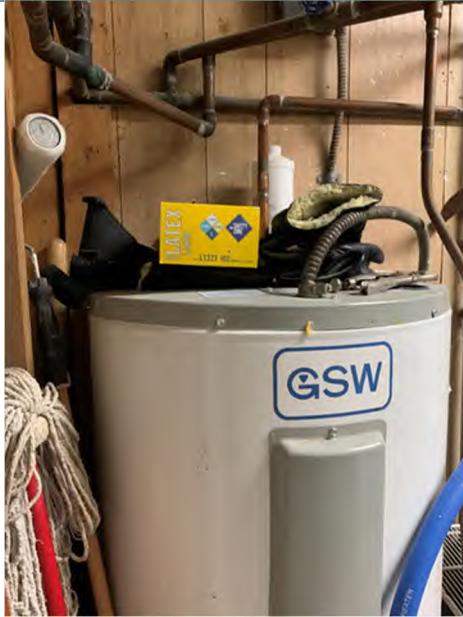
Domestic hot water is provided by a 4.5 kW 184 L GSW electric hot water tank installed in the Service Room downstairs. The unit was installed in 2005 based on its serial number and past its expected service life of 11 years. The plumbing fixtures in the main washrooms are in fair condition with some signs of corrosion. The main sanitary drainage and domestic water piping was concealed by interior finishes. There is storm pipe located in the Mechanical Plant Room that is connected to a roof drain above and in poor condition. The roof over the rink area is provided with gutters and downspouts.

Photo 59 | Curling Rink hot water tank

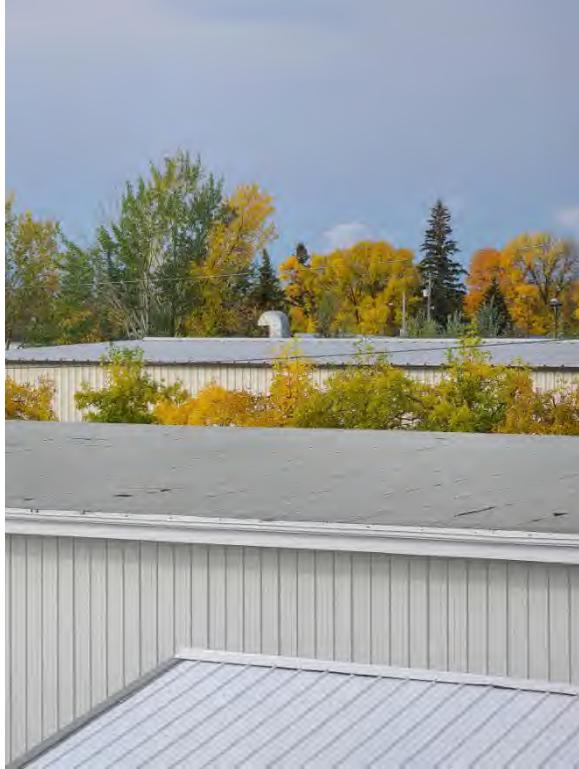
Photo 62

The roof of the Curling Rink was observed from the Arena's roof and from the exterior stairs to the slider. The roof appears to be in a good condition except for the roof over the entrance, where there are signs of water ponding. Typically small water ponding is not a structural concern. The snow weight on the roof is generally higher than the weight from water ponding. However, if the water ponding does not dry off, damage can occur to the roofing material.

General condition of the Curling Rink's roof

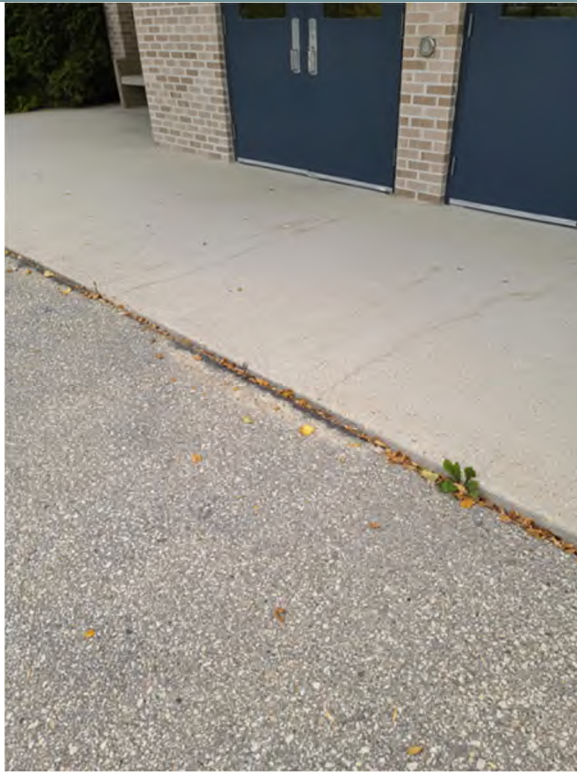
The building appears to be designed for accessibility. There was a small step observed between the concrete apron and the asphalt as well as between the concrete apron and the concrete path. The step at the path was previously repaired but due to the movement of the soil, this repair no longer provides safe access.

Photo 64 A small step between concrete apron and asphalt

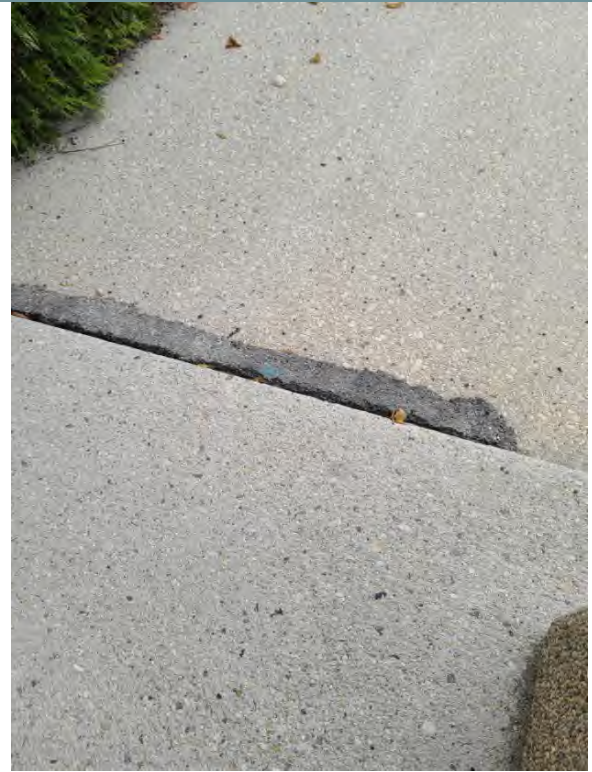
Photo 65 A step at the edge of concrete apron and concrete path

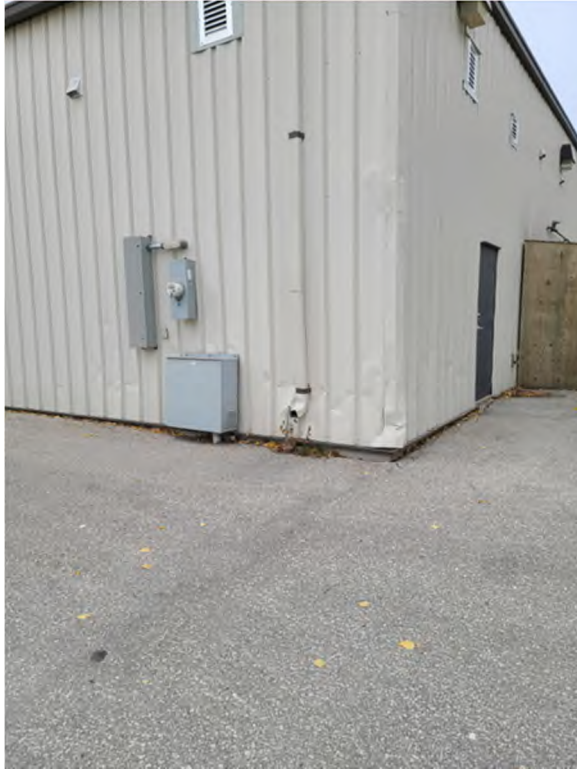
Similar to the Memorial Arena, the exterior wall panels suffer from being hit. However, these dents are not structural concerns and can be repaired if needed. The interior of the building appears to be in a good condition. There was a minor cut in the wall covering observed. No sign or report of any water issues. No reports of drafts at any openings.

Photo 66 Exterior wall panels

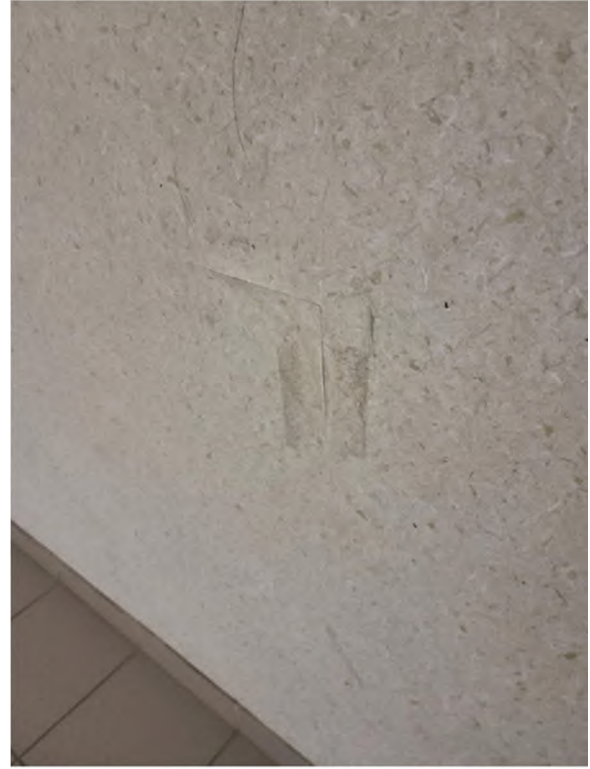
Photo 67 Minor cut on the wall

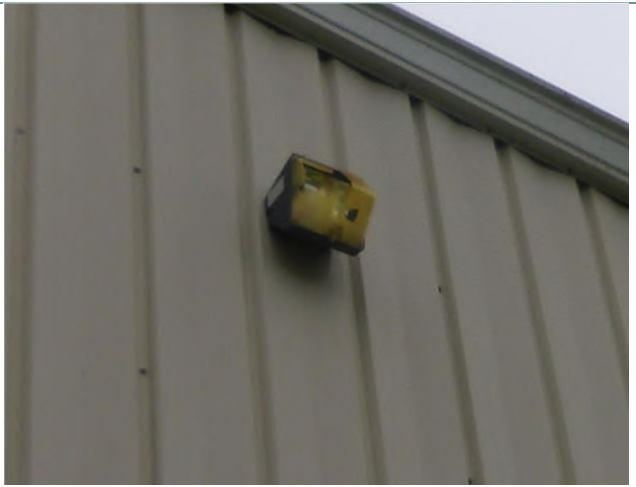
Photo 68 A light fixture at the back of the building has a broken lens and possibly broken lamp

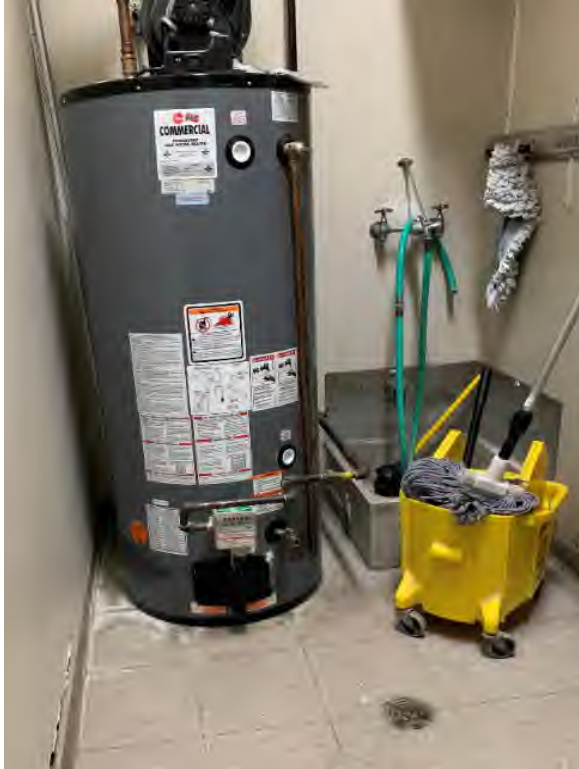
Hot water for the facility is provided by a natural gas fired domestic hot water tank installed in the service room. The tank is assumed to be original and has an expected service life of 15 years. The plumbing fixtures are assumed to be original to the building and are in good condition. The main sanitary drainage and domestic water piping was concealed by interior finishes. The drainage piping connected where visible was mostly PVC and the domestic water was copper. The piping is expected to last beyond 25 years assuming no external damage occurs. Natural gas piping is located at the facility to serve the air handling equipment and commercial kitchen equipment. The piping is expected to last beyond 25 years assuming no external damage occurs.

Photo 75 Hot water tank

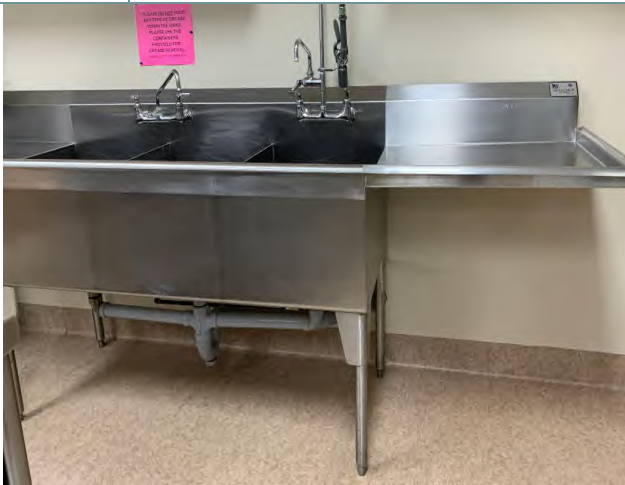
Photo 77 Plumbing fixtures

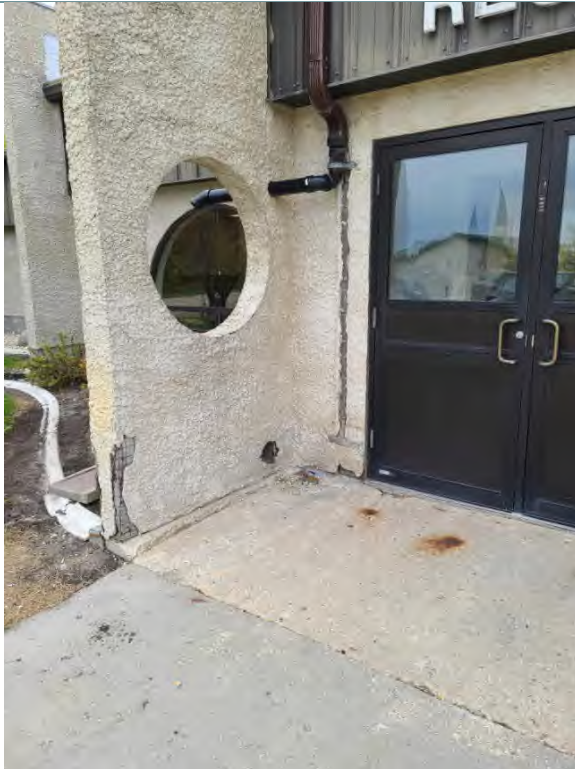
It is observed that the stucco in front of the building is in critical condition. Some has spalled off exposing reinforcement. According to the interview, this is on the repair list by the Province. Along the back of the Community Hall, the board insulation has been pushed up by frost. This causes damage to flashing on top of the insulation. It is not know why there are insulation boards along the north and west of the community hall and not anywhere else. The damaged flashing can cause water entering back into the building from the underside of the wall. The condition of the interior building appears to be in a good condition. This includes the Curling Rink.

Photo 80 Main entrance of the Community Hall

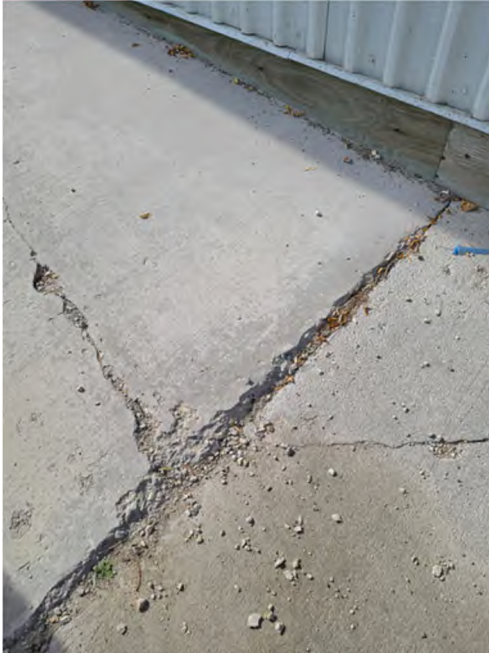
The concrete ramp is in a fair condition. Cracks and differential movement can pose a tripping hazard to users. There are a few locations where the concrete stair nose broke off. This can also pose a hazard to the users. A couple spots of damage were observed on the exterior wall. The damage exposed rigid insulation core. These damages are not of concern to the integrity of the panel as they are not big areas.

Photo 108 Ramp to the Arena

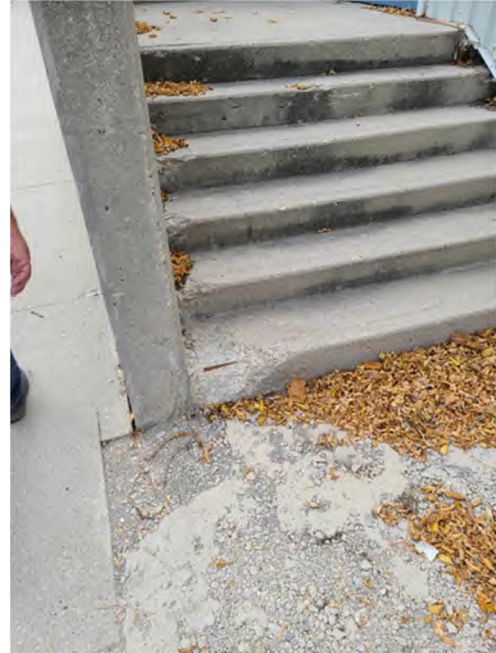
Photo 109 Damaged stair nosing

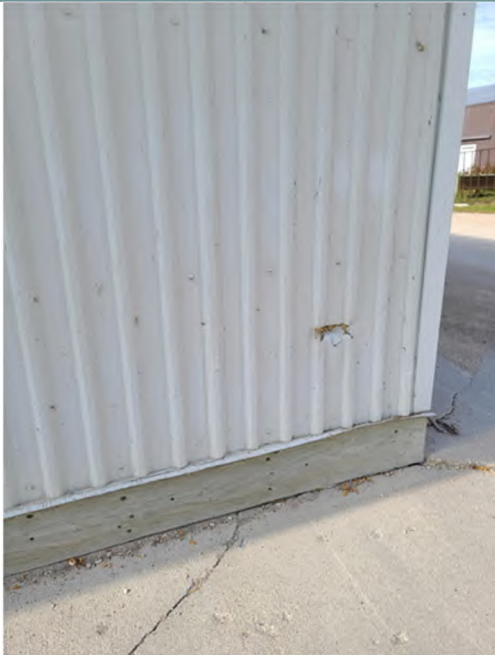
Photo 110 Damage to insulated panel

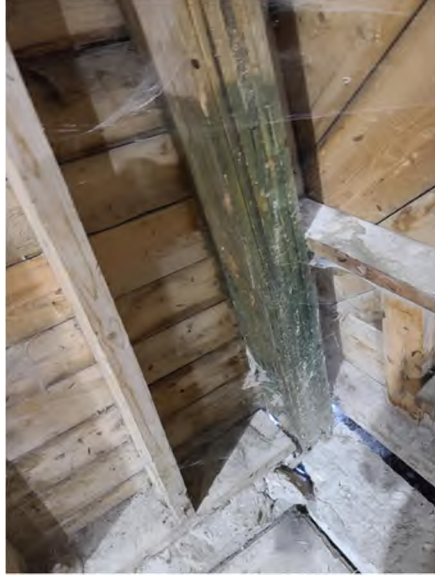
The general condition of the interior is fair to good. The Arena is uninsulated and there are gaps under the exterior walls. According to the interview, there will be snow piling against the wall during winter which helps prevent cold draft entering into the Arena. It should be noted that this is generally acceptable. However, regular monitoring should be made to prevent water penetrating into the building. It is understood that the water penetrating into the building had occurred in the past causing the main structural frame to rot. At these locations, new steel shoes were installed as seen in the photo.

Photo 111 Gaps underside of the exterior wall allowing air flowing into the building

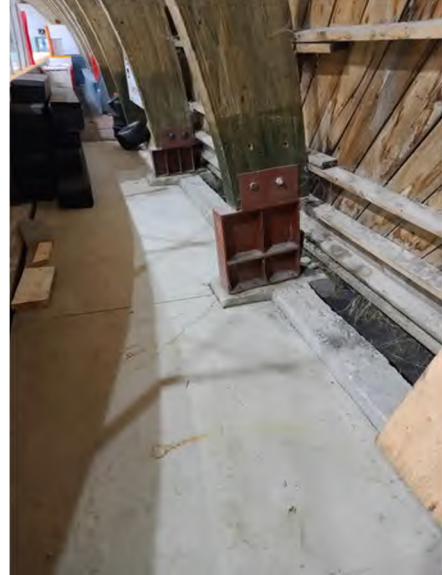
Photo 112 New shoes to the structural frame

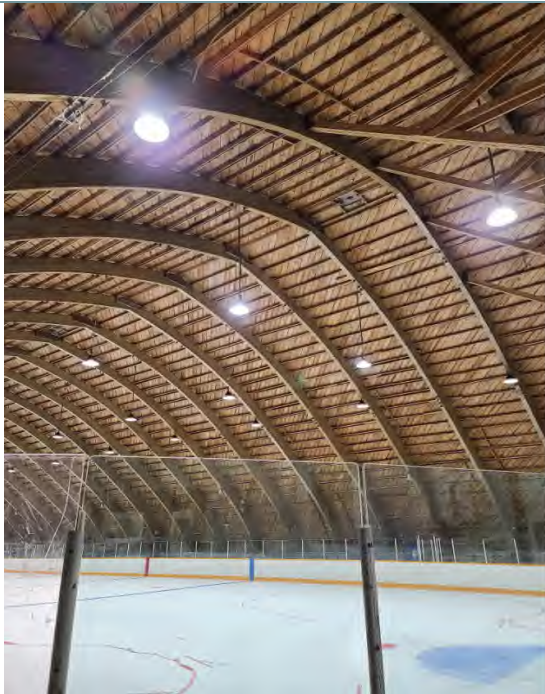
Photo 132

General condition of the structural framing of the Arena
