TOWN OF ARBORG AND MUNICIPALITY OF BIFROST-
RIVERTON

Facility Condition Assessment

Draft Report

Town of Arborg and Municipality of Bifrost-Riverton
Facility Condition Assessment – Draft Report

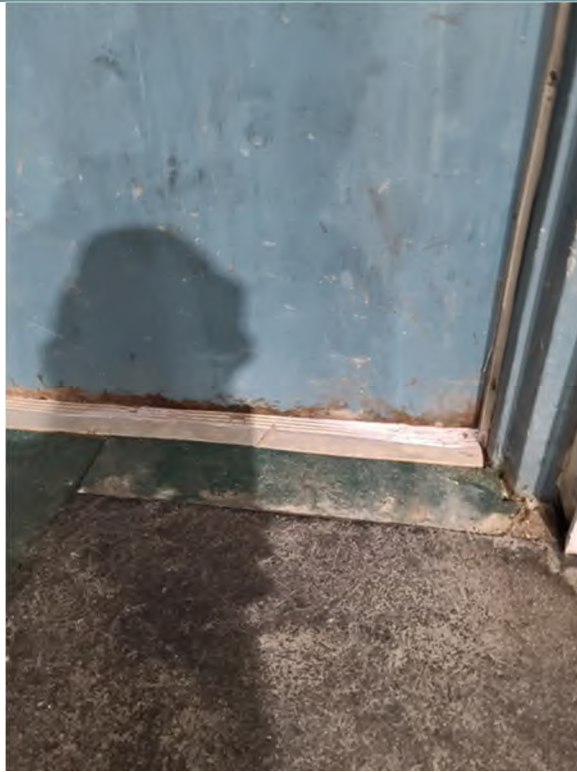
Photo 1

The general condition of the arena and the addition is good. The majority of the exit door thresholds appear to be not properly sealed. The wood walkway in the arena, although in good condition, poses tripping hazard to the occupants. The exterior wall panels appear to be in a good condition. Several dents are observed on the walls. These dents reduce the aesthetic but do not post a concern to the building envelope.

A gap at an exit door threshold

- All the damage to the exit door trims and gaps at the exit door thresholds be repaired as soon as possible; and
- Locations of the uneven wood walkway should be remedied to prevent any injury to the occupants as soon as possible.

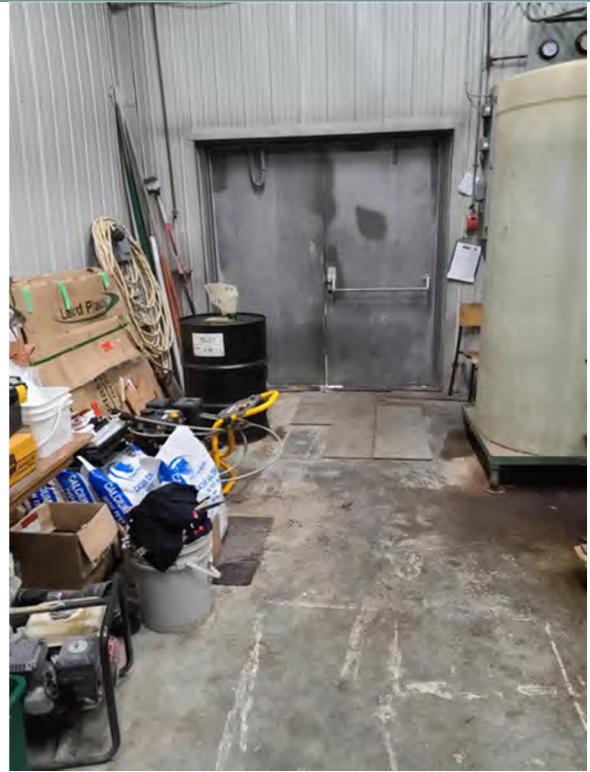
Photo 2

Gap at exterior door threshold in the ice plant

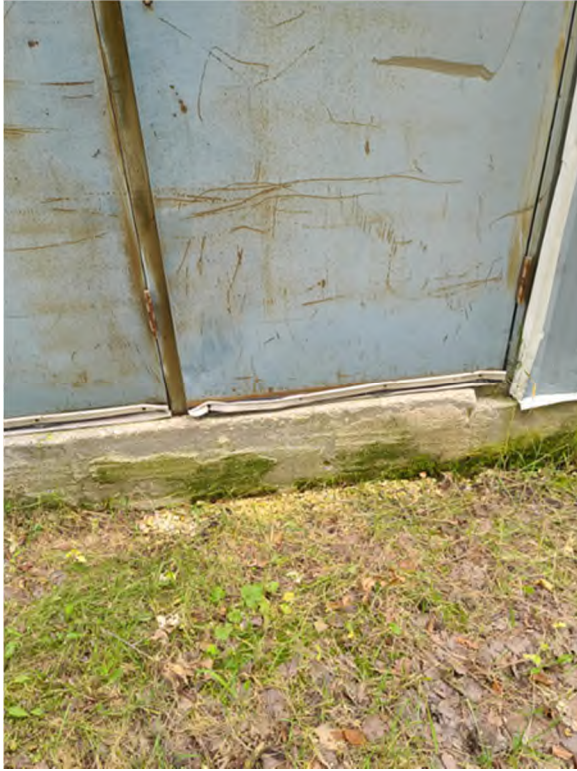
Photo 3 Exterior of an exit door

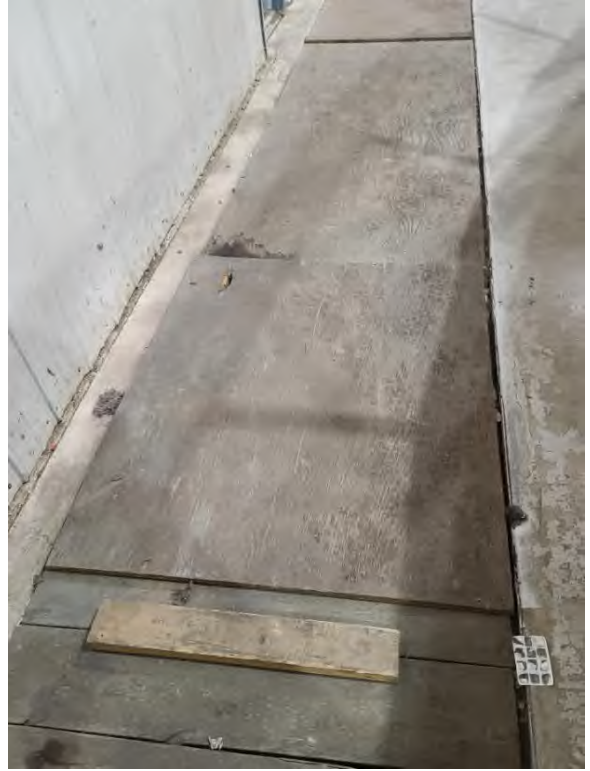
Photo 4 Wood walkway in the arena

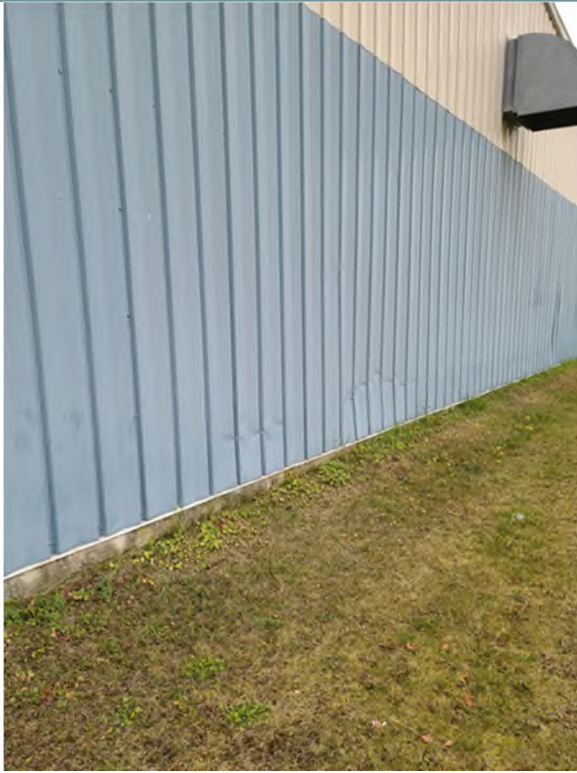
Photo 5 Typical exterior wall panels

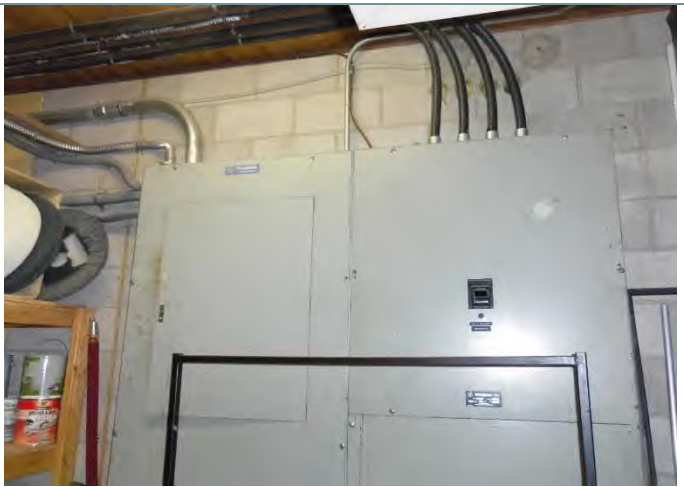
Photo 6

Electrical panel in Electrical Room

The existing CDPs in Electrical Room #1 and 3 are in good condition, with very little surface rust and blank circuit breaker spaces have a filler plate installed. The CDP's and panelboards have no visible damage such as bent cover plates or broken hinges. The end of service life for this distribution system is near and should be replaced.

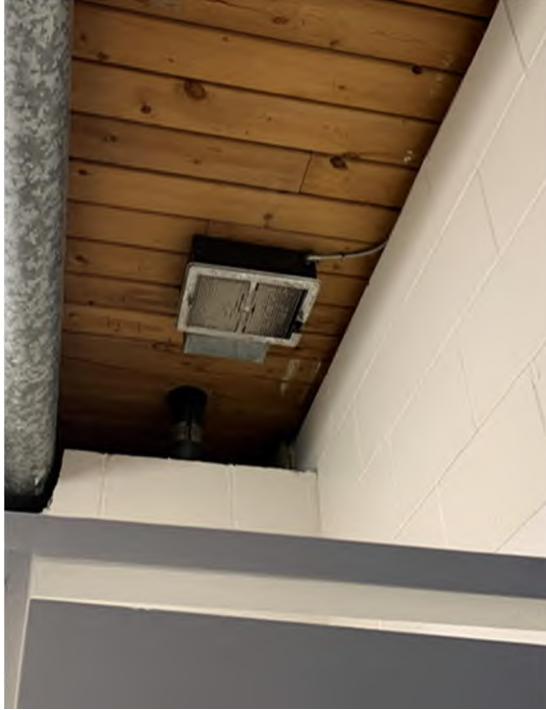
Photo 11

Electric force flow heater in washroom

Supplemental heating in the washrooms and entrance areas is provided by electric baseboard and force flow heaters. The units are in fair condition and past their expected service life of 10 to 15 years.

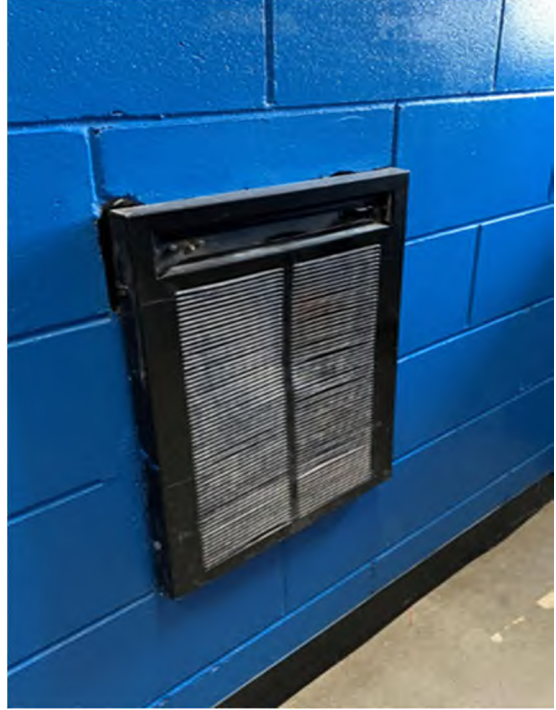
Photo 12

Electric force flow heater in entrance

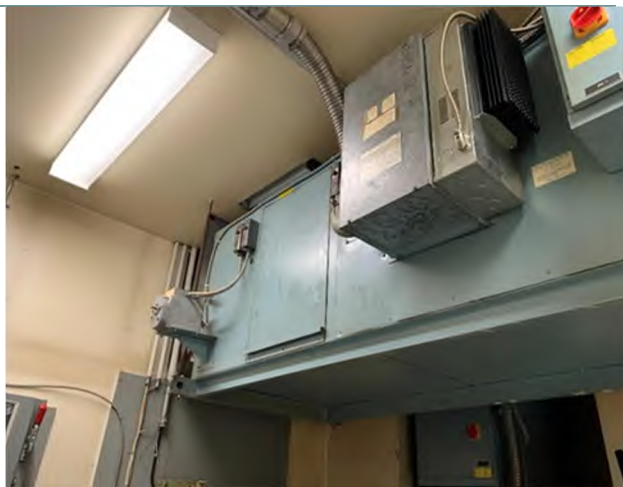
Photo 13

The Lobby and Office Area added in 1990 is served by two air handling units installed in Electrical Room #3. Primary ventilation and heating for the Lobby and Offices is provided by AH-1. AH-1 is an ICES Model BMA-E50 with 60kW SCR electric heating coil. The unit provides 2500 CFM of mixed air through ductwork concealed in the ceiling space. The unit was not operating during the site visit. The life expectancy of this unit would be 15 years.

Air handling unit in Electrical Room #3

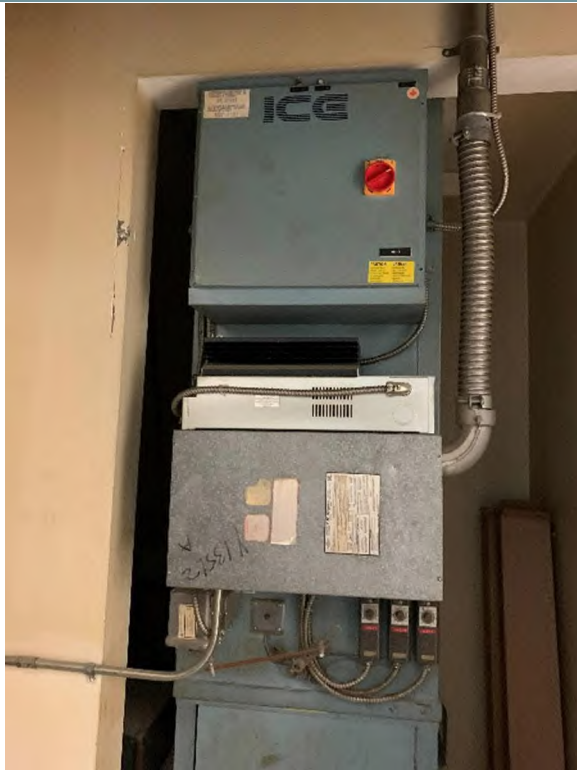
Photo 14

The Lobby Area contains a commercial kitchen with a hood and roof mounted exhaust fan. The exhaust fan, F-1 is a Penn model FMX 12Q with a rated capacity of 1800 CFM and is operated manually with a wall switch. The hood is equipped with a fire suppression system last reviewed in 2020. Make-up air to the kitchen is provided by an AH-2. AH-2 is an ICES model BMA-E10 makeup air unit with a 50 kW electric heating coil. Its operation is interlocked with F-1. The units were not operating during the site visit. The life expectancies of the air handling unit and exhaust fan are 15 and 20 years, respectively.

Kitchen air handling unit

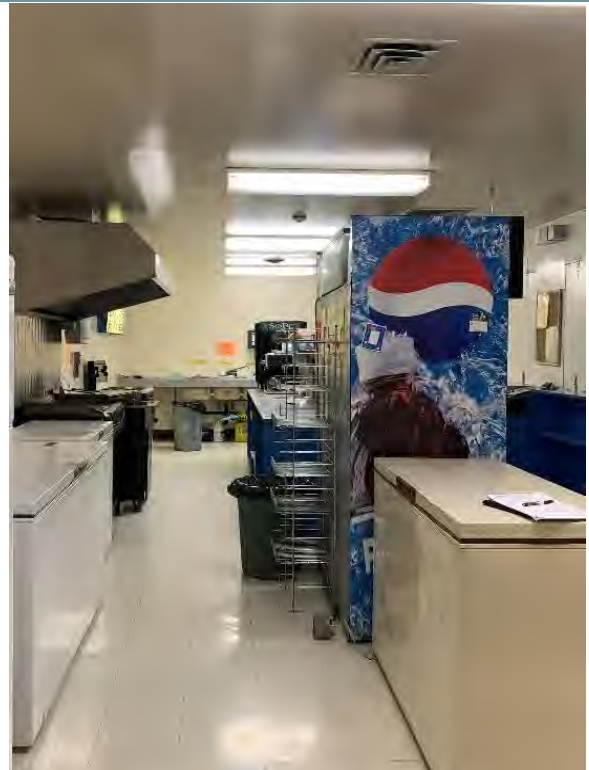
Photo 15

Kitchen exhaust fan

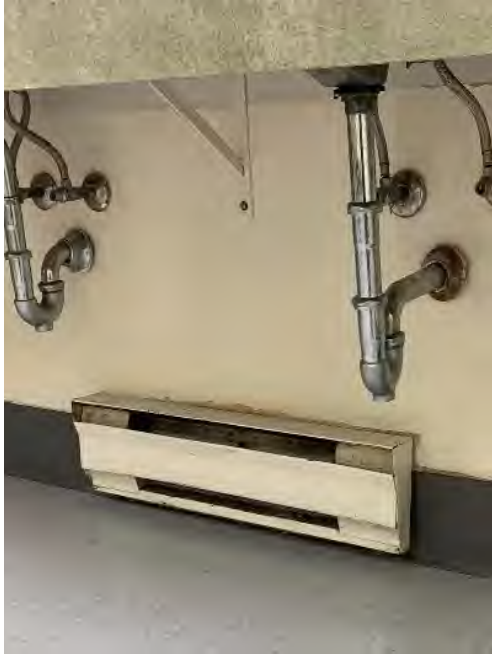
Photo 16 Bathroom baseboard heater

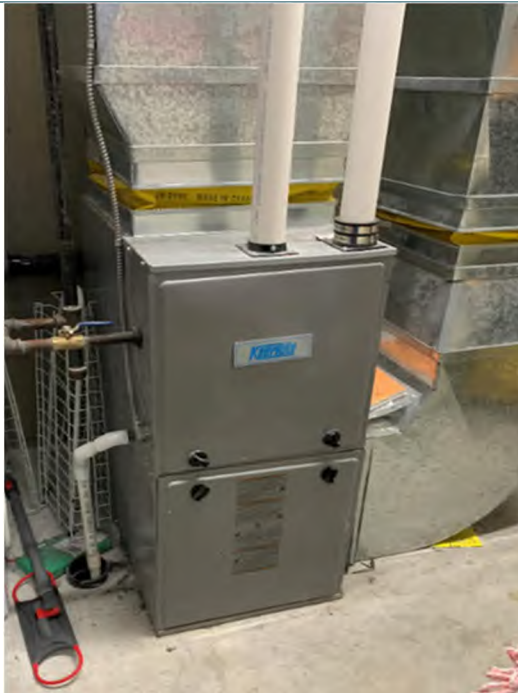
The new Dressing Rooms completed in 2017 are served by a natural gas furnace installed in the Service Room. The unit is a KeepRite ICP Model N9MSE and has an expected service life of 18 years. Supply air is provided to the dressing rooms through exposed duct work and grilles.

Photo 17 Dressing room furnace

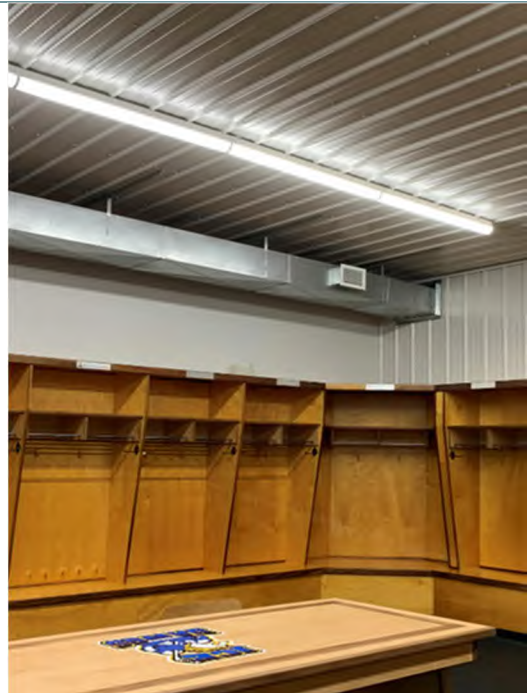
Photo 18 Dressing room duct work and grilles

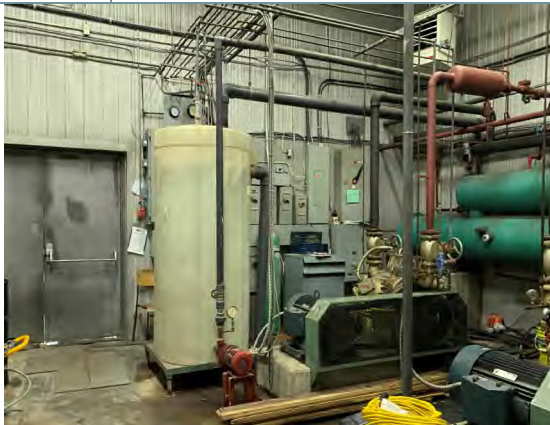
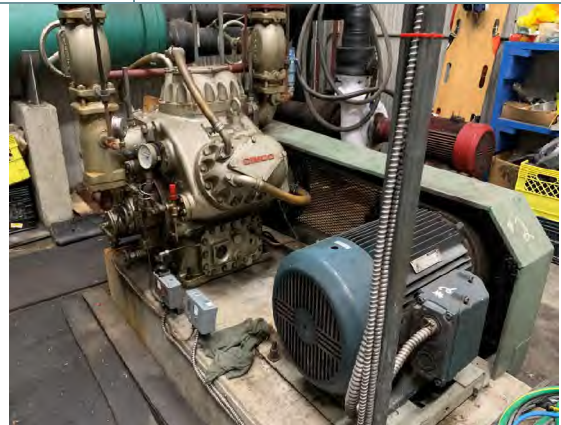
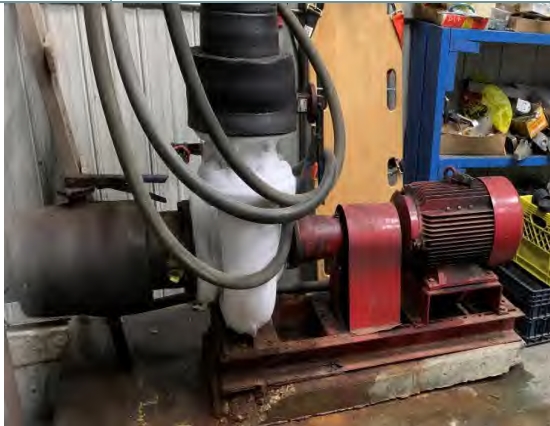
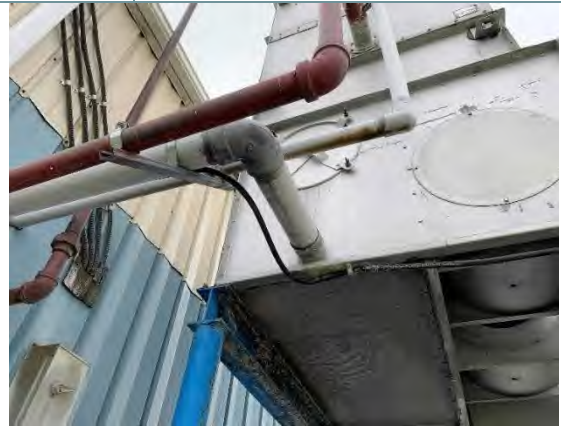
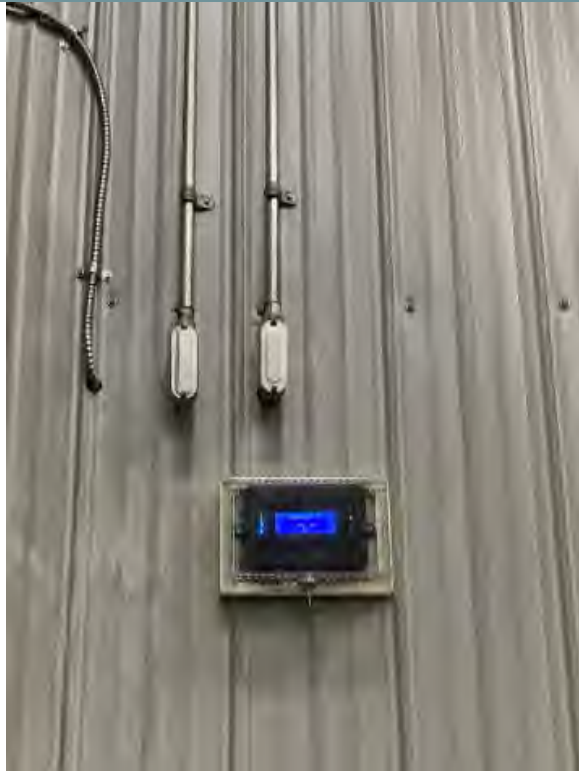
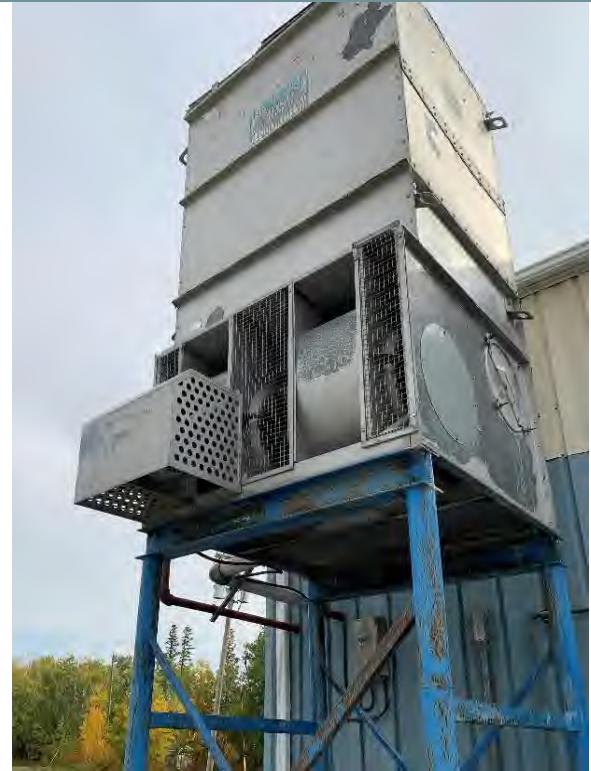
The arena has a 35.9 ton indirect mechanical cooling plant that contains two (2) N6WA Cimco Mycom ammonia compressors, two (2) 50 hp GEC motors, Cimco MK15 chiller, 2 hp brine pump, brine tank, evaporative condenser and supporting electrical and controls equipment. The equipment was installed in 1986 and has required no major upgrades beyond routine annual maintenance. The rink piping was not visible during the site review but no concerns or leaks were noted. The plant room is equipped with gas detection and ventilation. The gas detection system is assumed to be only a couple years old and was operating during the time of the site visit. The mechanical cooling plant is well beyond its expected service life of 25 years.

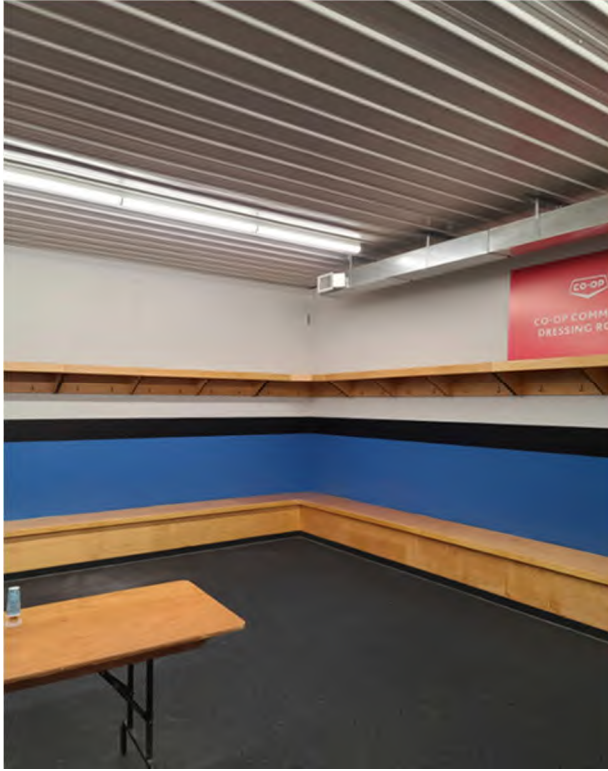
Photo 33

Pre-cast concrete wall panels and steel panel ceiling of the Co-op Community Dressing room addition to the Arena

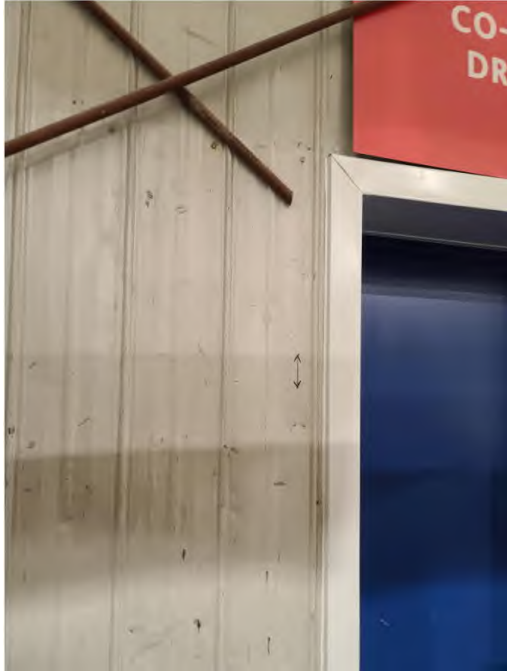
Photo 34

The construction of a co-op community dressing room addition in 2017 appears to be violating the integrity of the arena's structure. This is noted as one of the structural bracings was cut for the opening to the dressing room. Bracing is a system in a pre-engineered steel building designed to transfer lateral load from wind. At a minimum, bracings are provided on three sides of the building and at roof level. There may be one or more bracing locations on one side. When one bracing is cut, the load will transfer to the remaining bracings. If the remaining bracings are designed to their capacity, the additional load will exceed their capacity and can cause failure to the structure. It should be noted that the wind pressure used in the design, according to the National Building Code of Canada, is based on a one-in-fifty-year value. It is, however, assumed that the engineer who designed the addition has taken this into consideration. Note that the addition was constructed with pre-cast concrete panel walls. If the connections are properly designed, the lateral forces will be transferred to the walls of the addition. As there is no documentation on this addition and that the scope of work does not include analysis of the structure, only an observation is reported herein.

One of the cross bracing was cut for an opening to Co-op dressing room.

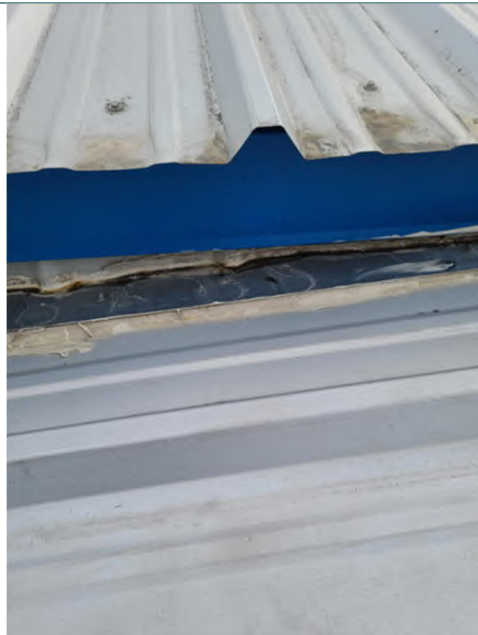
Photo 35

According to the interview, there are three locations where water leakage occurs in the Co-op dressing room and hall way. Investigation was carried out on the roof of the building and it is observed that there were damp spots along the caulking between the arena building and the addition.

Roof connection between the arena and the addition

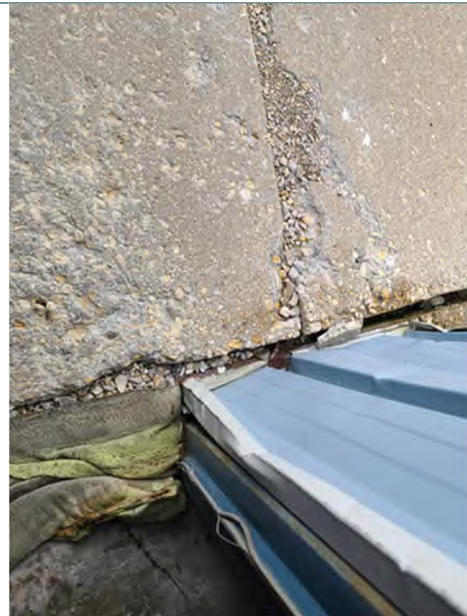
Photo 36

The exterior door threshold

It is observed that the concrete at the exterior door threshold in Olympia room is in a poor condition. According to the facility manager, this door threshold will be repaired within a few weeks.

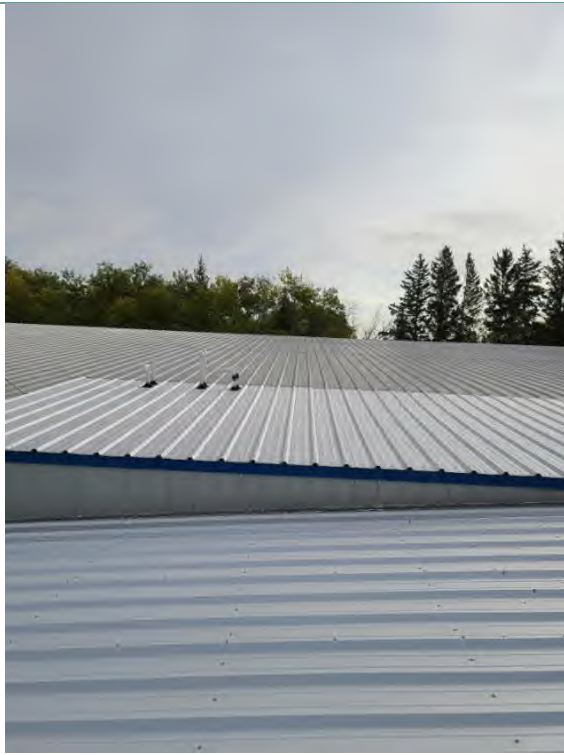
Photo 37

The roof of the arena and the additions appear to be in a good condition.

General condition of the arena and the addition roofs

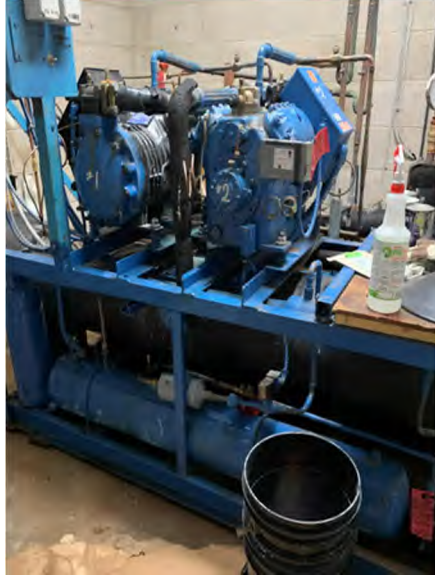
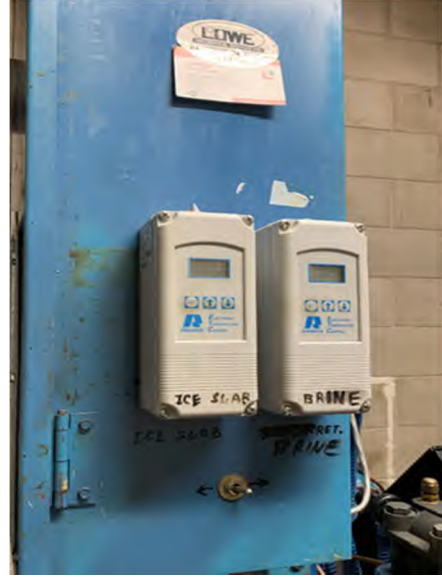
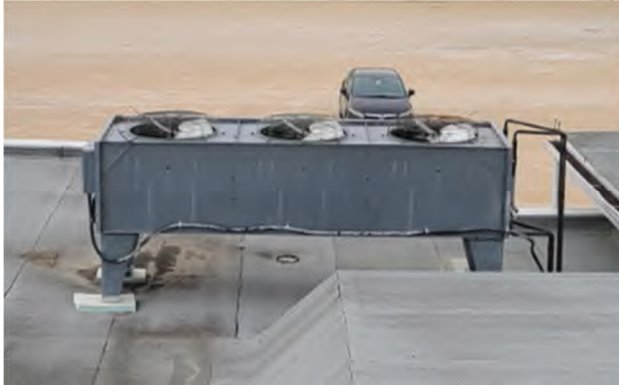
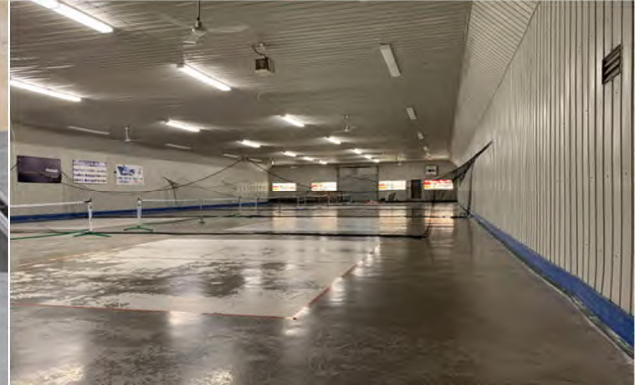
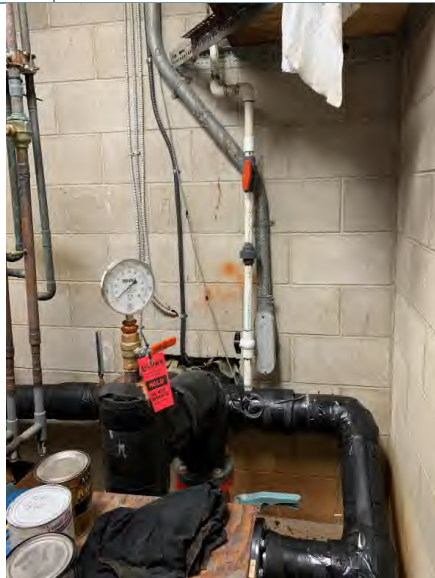
The ice rink has an indirect mechanical cooling plant that contains an R-22 Fleming Pedlar system with two compressors, brine pump and tank and roof top air cooled condenser. The exact age of the system is not known but it is assumed to be over 25 years old. The brine pump was replaced in 2019 and one of the compressors was recently overhauled. The expected service life of the plant equipment is 20 years. The R-22 is currently being phased out in North America and as of 2020 the refrigerant will no longer be in production. Replacements of systems currently using R-22 are not required but the cost and availability of the refrigerant may increase over the coming years. The plant room does not contain a ventilation system.

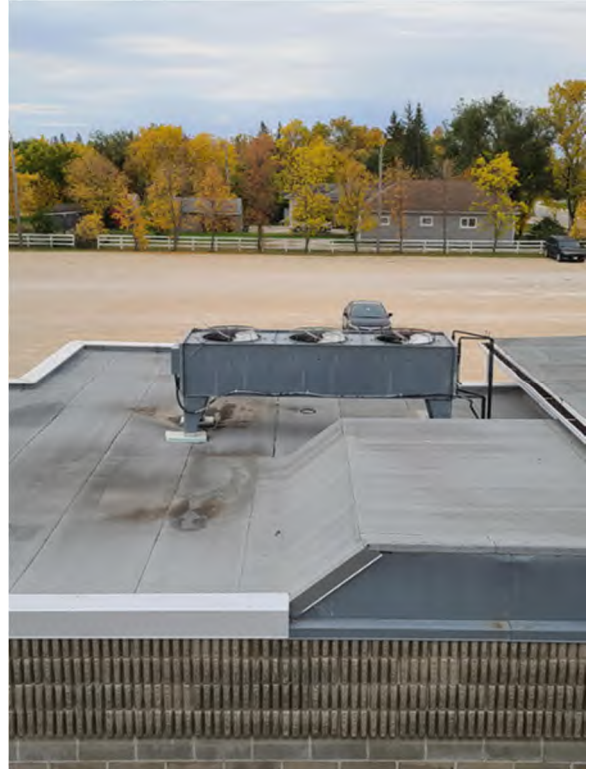
Photo 63

Sign of water ponding on the flat room

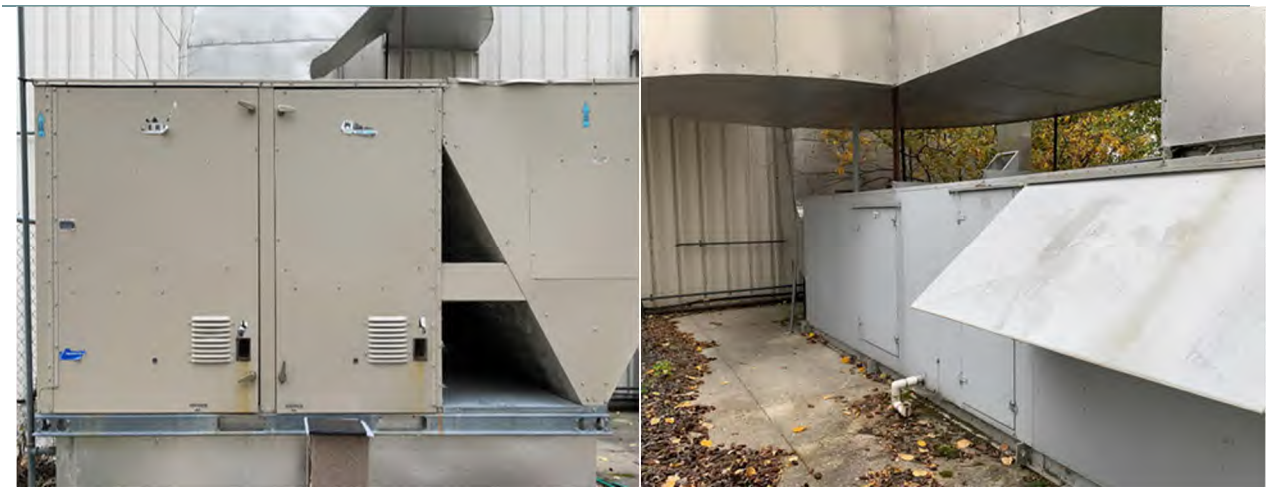
Photo 69

East side HVAC unit

West side HVAC unit

- Replacement of the Air Handling units can be expected within one to five years or once maintenance/servicing frequency increases. A cost allowance for this replacement has been provided. Continue on-going maintenance/servicing of the equipment until replacement.

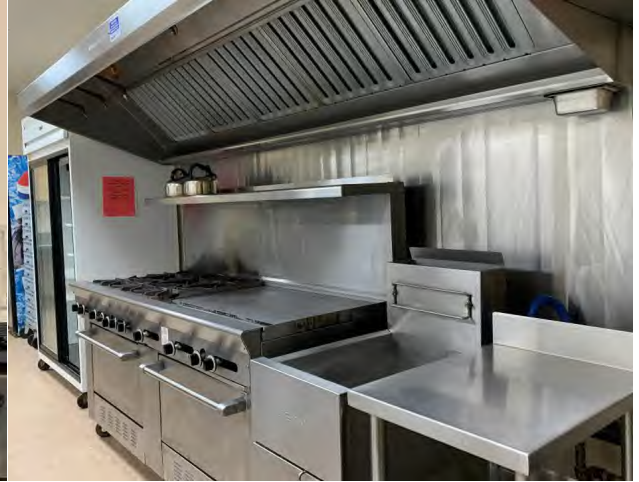
Photo 72

Kitchen hood and exhaust fan

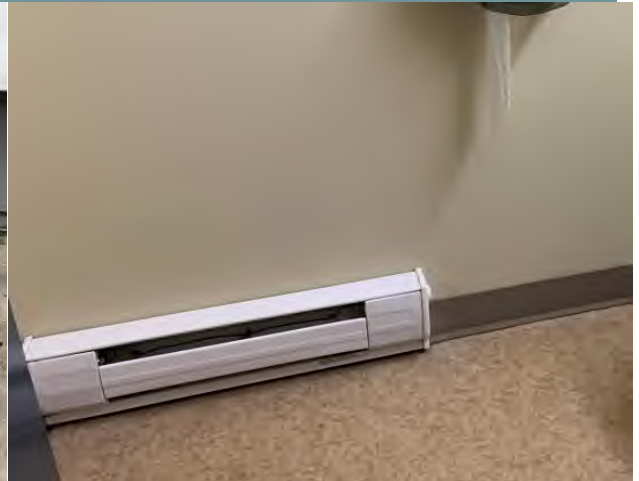
Photo 74

Supplemental heat in entrances and washrooms is provided by electric baseboard and forceflow heaters. The units appear to be in good condition but are past their expected service life of 10 to 15 years.

Baseboard heater

- Replacement of the electric heating units can be expected within one to five years or once maintenance/servicing frequency increases. A cost allowance for this replacement has been provided.

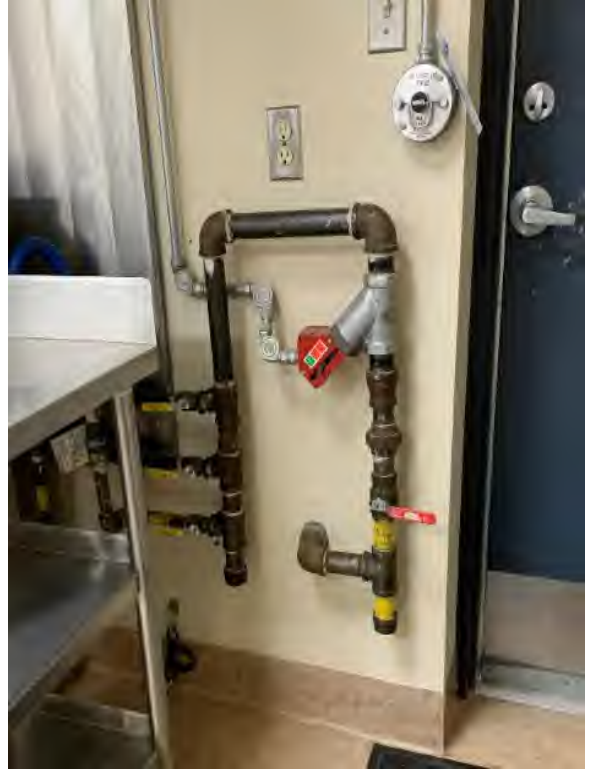
Photo 76 Drainage piping

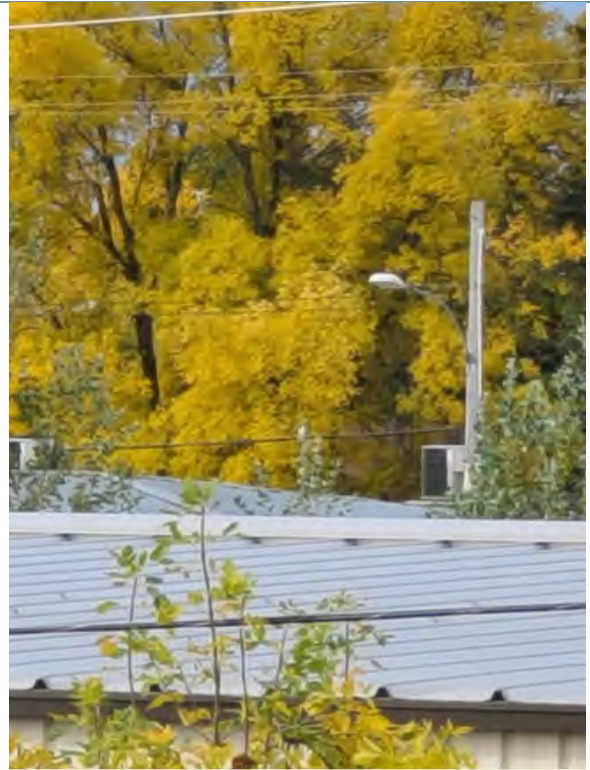
The assessment of the roof was carried out from the Arborg & District Arena roof. Only part of the roof could be seen. Photos are reviewed. In general, the roof looks to be in good condition.

Photo 79 Roof of the Community Center

There are no recommendations for structural upgrades at this time.

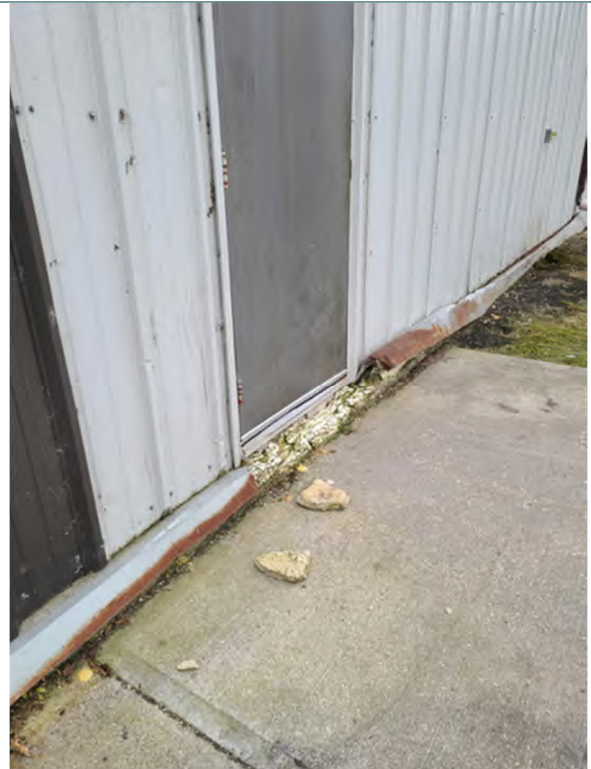
Photo 81 Heaving of board insulation pushing up flashing at the base of the walls

It is recommended that the flashing along the north and west of the building be repaired within five years.

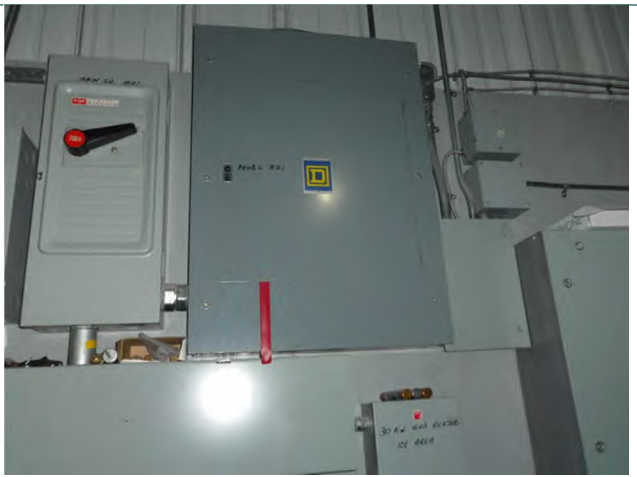
Photo 82

The electrical distribution was installed 1989 to 1990 with new sub-distribution panels and transformer and panels installed later in the lobby area.

The original distribution system components that are still being used for distribution should be replaced with new CDPs, splitters, panels and disconnect switches as they have reached their expected lifetime limit.

Electrical panelboard

- The panelboard be replaced;
- The fluorescent lighting to be replaced with LED lights;
- The receptacles to be replaced by GFCI receptacles; and
- Provide better lighting to the stairs.

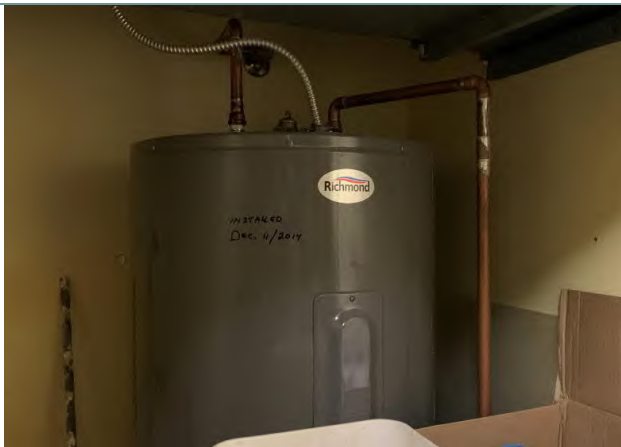
Photo 91

Domestic hot water is provided by Richmond electric hot water tank installed in the service room. The unit was installed in 2014 and has an expected service life of 11 years. The plumbing fixtures in the main washrooms were recently upgraded and are in good condition. The remaining fixtures appear to be older and in fair condition with some corrosion noted. The main sanitary drainage and domestic water piping was concealed by interior finishes.

Hot water tank

- The hot water tank serving can be expected to be replaced within the next year or when maintenance/servicing frequency increases. A recirculation pump should be included to ensure timely delivery of hot water to fixtures. A cost allowance for this replacement has been provided.

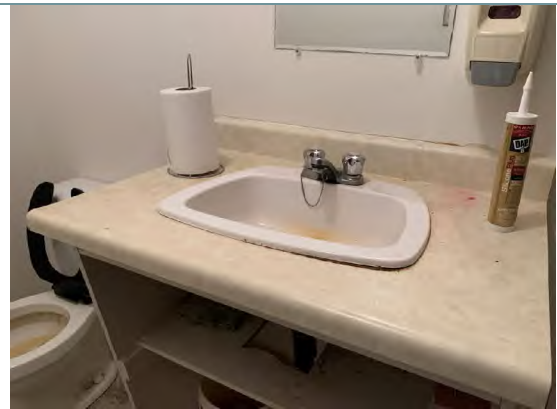
Photo 92

Washroom plumbing fixtures

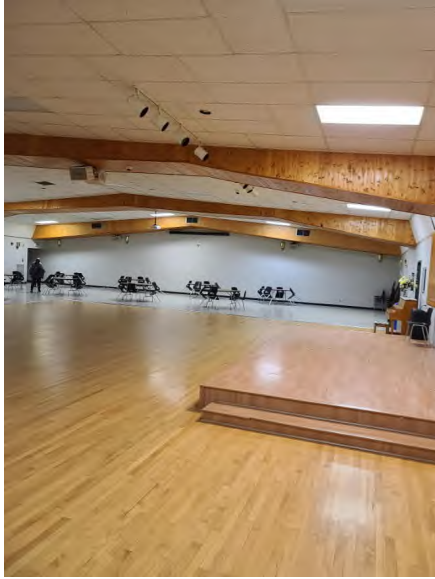
Photo 106

The buildings are pre-engineered steel framing. The framing of the Community Hall is covered by the architectural cladding all around. Therefore, the structural components cannot be assessed. The framing of the Curling Rink is exposed and is in a good condition. Based on the interview, there is no sign of water leakage or any concerns.

Structural steel framing in the Community Hall is covered

There are no recommended upgrades for the buildings at this time.

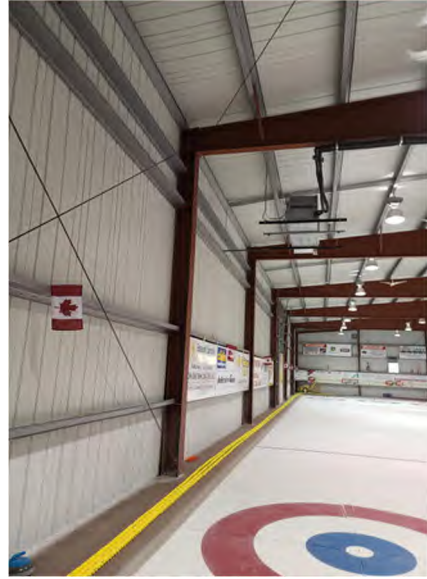
Photo 107

Structural steel framing of the Curling Rink

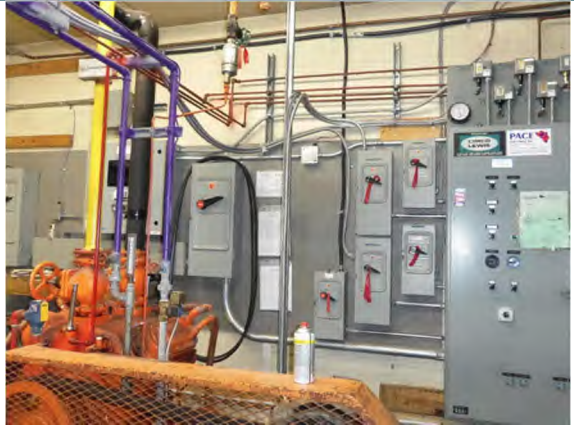
Photo 113

The ice plant distribution has reached its expected life cycle and should be replaced with new equipment.

Ice plant electrical distribution

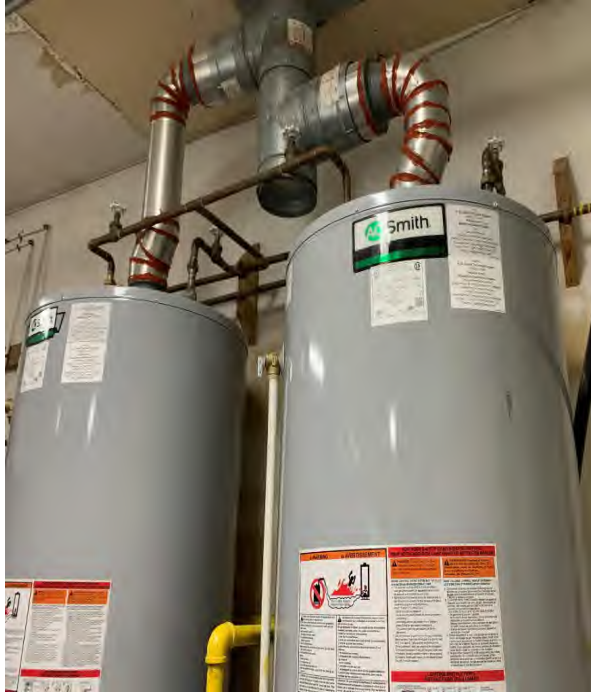
Photo 130

Two natural gas fired AO Smith hot water tanks are installed in the Maintenance Room. These tanks provide hot water for the rink flooding and maintenance and were recently installed. The system is equipped with a recirculation pump and expansion tank.

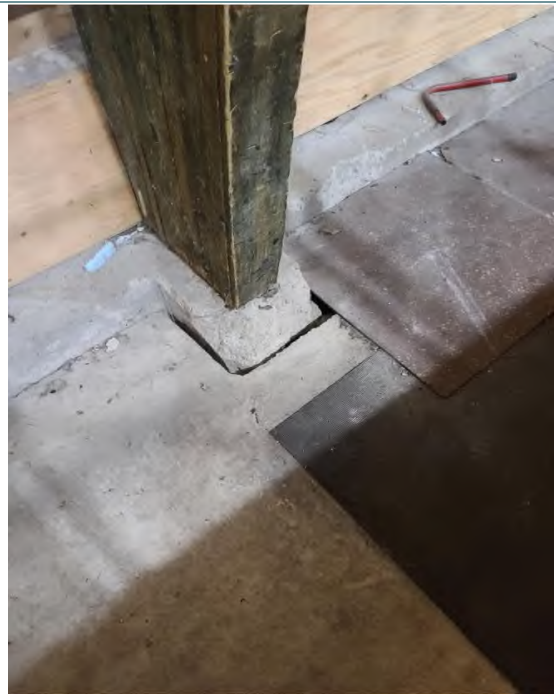
Photo 133

The general condition of the structural components are fair to good. There are several locations where concrete grade beams and pilasters have spalled off. The grade beams are designed to provide a connection between the pilasters, receiving the dead load of the walls and contain the interior slab. The pilasters are the supports for the superstructure framing and are designed to transfer the loading from the framing to the foundation.

Damages of the concrete grade beam and the pilaster

- The concrete grade beams and pilasters be repaired as soon as possible. The repair procedure includes removing the deteriorating concrete, shaping the surface to provide straight faces with no edge feathering, scarifying the concrete surfaces to provide better bonding to the new concrete, saturating the surface, applying bonding agent and placing new concrete.
- Anchor bolts should be provided to steel shoes as soon as possible. Note that there are already existing holes in the base plate of the steel shoes. The anchor bolts should be at minimum 350 mm long and be drilled and inserted into the concrete pilaster using Hilti Hit HY 200 adhesive. The embedment of the anchor bolts to the pilaster should be at a minimum of 250 mm. At a minimum, four anchor bolts should be provided for each shoe.

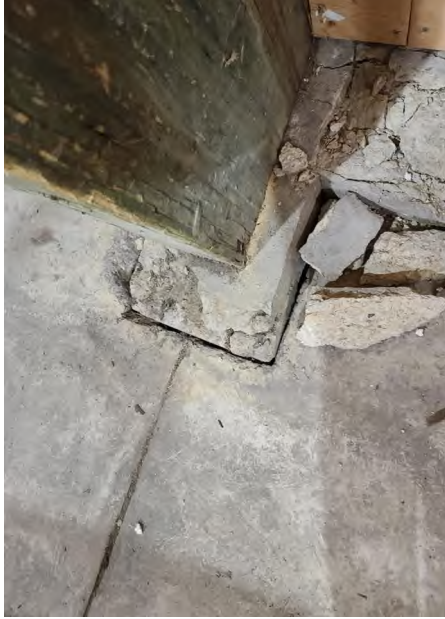
Photo 134

Spalling of the concrete grade beam and pilaster

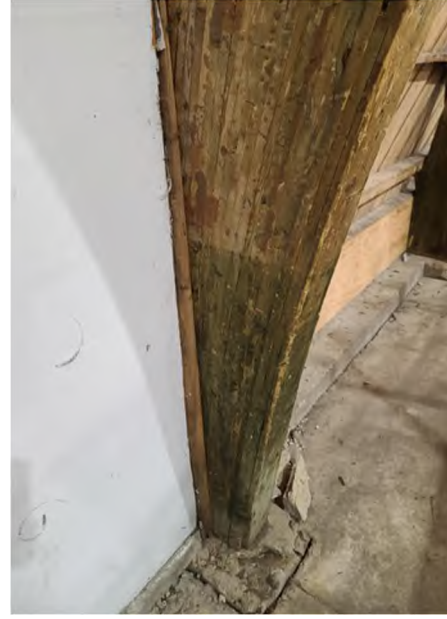
Photo 135

Spalling of the concrete pilaster

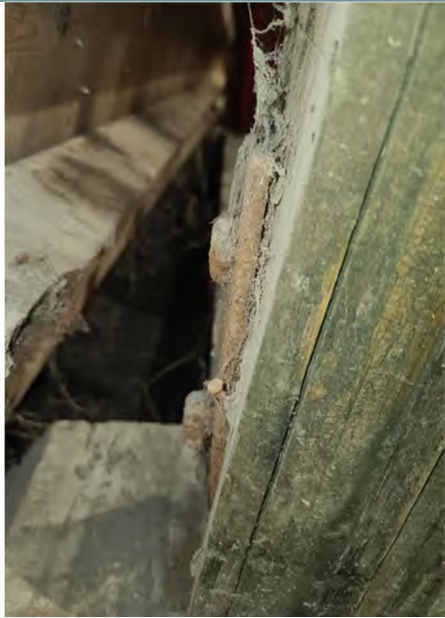
Photo 136

The photo below shows a steel plate embedded into the concrete pilaster which is designed to transfer the kick out force from the wood framing to the foundation. This steel plate is fastened to behind the wood frame. However, at the new steel shoe locations, the shoe was placed in front of the steel plate without connection to the shoe. With time, the frame starts to move out from kick out force causing the plate to bend outward.

A steel plate behind wood framing column

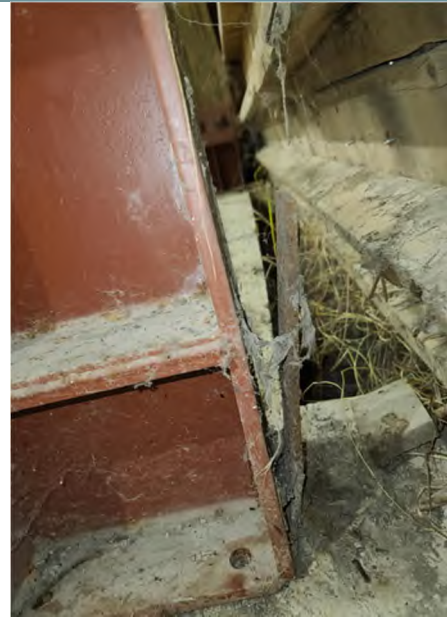
Photo 137

Steel plate behind the steel shoe

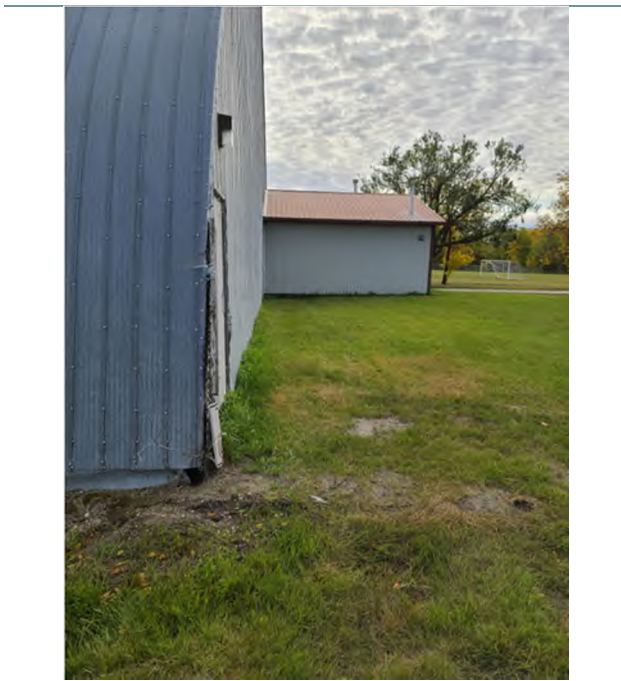
Photo 138

It was observed that the grading on the west of the arena slopes towards the building. The grading on the south-west side of the building could not be observed as it was covered with vegetation at the time of the inspection. According to the interview, a swale was installed along the north of the building. The site observation showed that this swale, as seen in the in the photo below, does not connect to the location where the grade slopes down away from the building.

Grading along the west of the building
(rear of the building)

It is recommended that the grading behind the Arena be corrected as soon as possible. This can be done by providing a swale along the building wall and connect this to the lower point in the back of the building. As well, if the grade along the south side is higher than the building base, it is also recommended that a swale be provided to drain the water to the low point away from the building to prevent water entering into the building.
